EVALUATION OF ANTI-CORROSIVE MATERIAL AFTER AGEING

ABSTRACT: The ageing of material in many cases can cause failure or disaster of mechanical parts of machines before the time of product life. It means the great waste for producers and firms. The contribution deals with the evaluation of applicability of anticorrosion material stressed in deformation background and thermal ageing. The applicability of material in mentioned surroundings was tested by principal mechanical tests for one-axis tension and by metallographic evaluation. The contribution deals with the evaluation of applicability of anticorrosion material NICRO 52,6 stressed in deformation background and thermal ageing.

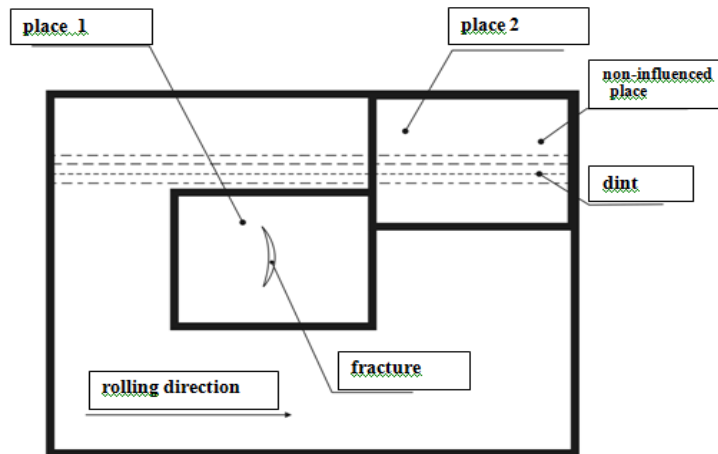
Figure 1. The scheme of drawing off the samples

In the Fig. 1 is shown the chosen places of each taking off of testing samples, where were the most often brakings, dints and failures of materials.

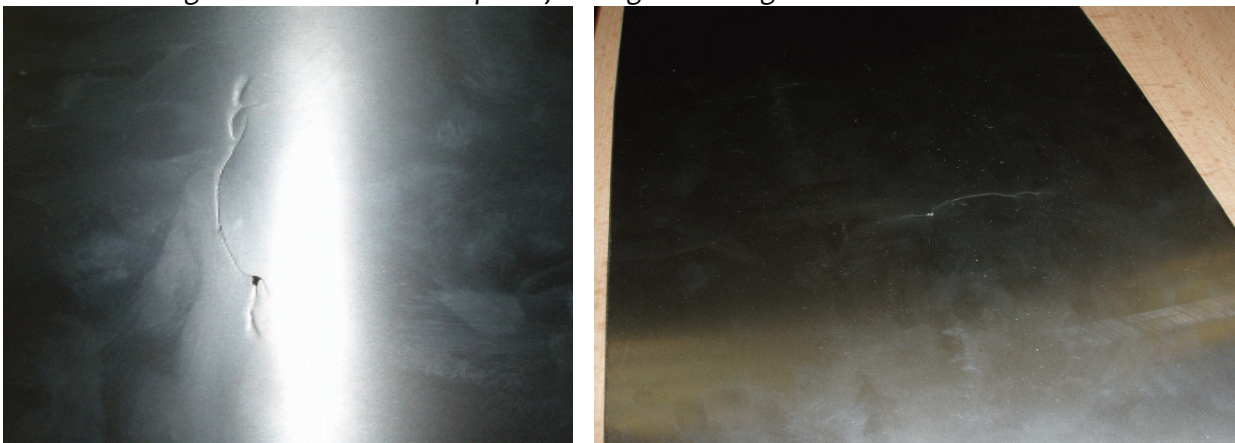
In the Fig. 2 are shown the examples of damaged bending belts.

Figure 2. The examples of fracture of bending belts

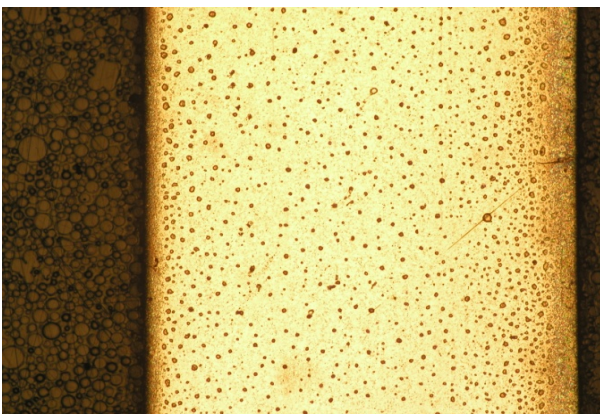
From the place 1, according to Fig. 1 were taking off the sample of non-influenced material, as it is shown in Fig. 3 and Fig.4, the structure of material is balanced. The decomposition of carbides grains of material is balanced. The Fig. 5 and Fig.6 show the thermal influence of material, where the chipboard and sheet have a contact by drawing of chipboard into machine. In the Fig. 6 is shown the detail of arising of inter-granular corrosion.

Figure 3. Balanced structure, ext.50 x

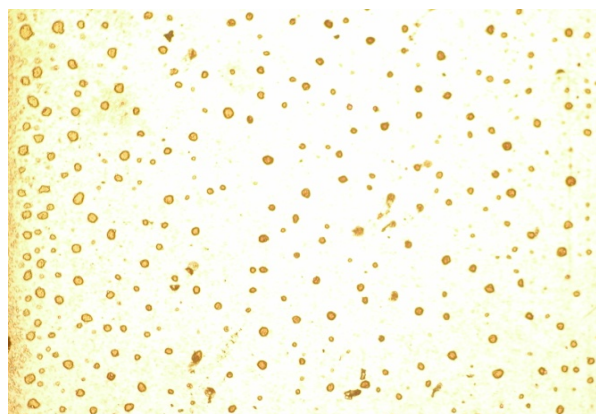
Figure 4. Balanced structure, ext.100 x

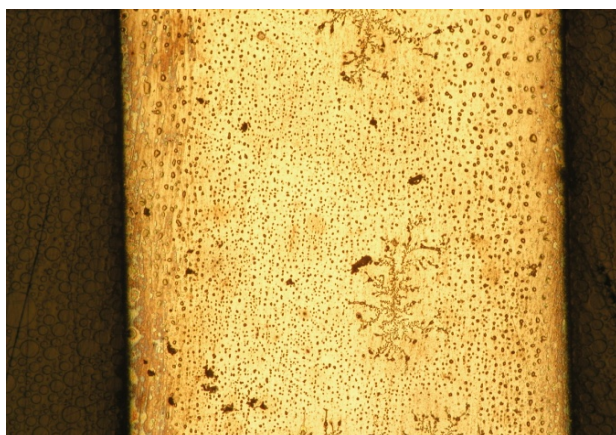
Figure 5. Intercrystalline corrosion, ext. 50x

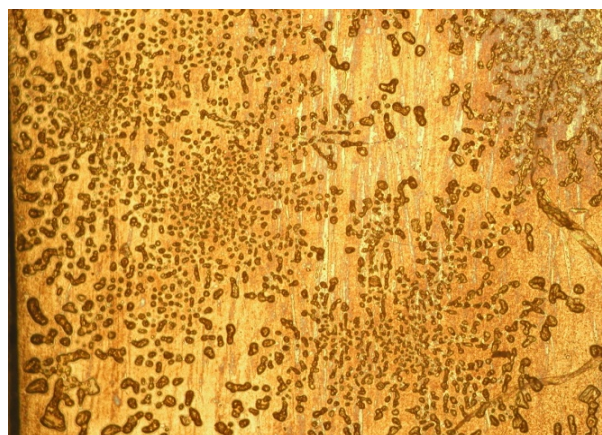
Figure 6. Detail of intercrystalline corrosion, ext. 100

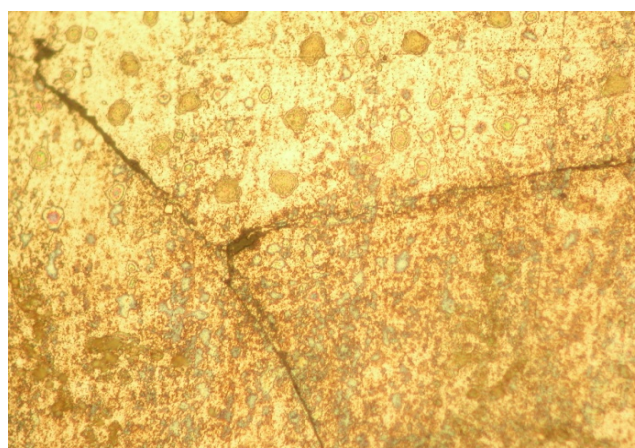
In the Fig. 7 is shown the detail of crack propagation at magnification 100x. The crack is spreads under 45° angle according to direction of loading, it means movement of strip.

Figure 7. The nucleus of crack propagation of material, 100x
