## ELIMINATION OF INCORRECT LEVEL (GAP) BETWEEN RR GATE AND RR BODY, BASED ON DEMING CYCLE AND STATISTICS TOOLS - CASE STUDY

**ABSTRACT:** The current investigation has an objective to present a methodology solution to eliminate the incorrect level (gap) of clearances and gates from the Rear Gate and Rear Body Side made during the auto motor vehicle manufacture. Based on the PDCA Control Cycle (Deming Cycle) and supported on the application of the process statistics tools, the activities were scheduled in order to systematically resolve the issue in the product's box. Applying the methodology, the planned activities were implemented to eliminate the problem and the impact of the incident was 100% effective, the main obstacle was the low model production volume, but eliminated the problem. The established work methodology to non-conforming elimination is a solution proposal that it has been documented in books, however currently, is a better option to implement FTA (Factor Tree Analysis) instead of the Ishikawa diagram in order to achieve a methodology of solution more efficient, achieving a work proposal that allowed the total elimination of the issue presented.

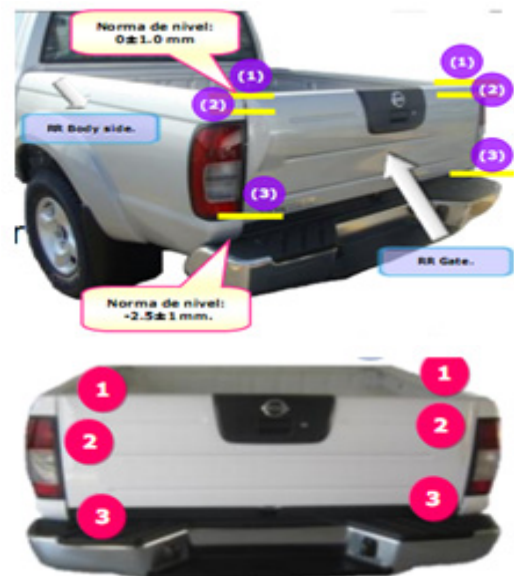
Figure 3. Location of the incident, source SIICA

Subsequently passed to the next process "mechanical groups", in which is incorporated the box assemble on the chassis and installs the retention mechanism and closure (striker). When the product is evaluated, quality results reported in the final line indicate the difference of the heights that are out of the specification among the parts mentioned in the gate. The incorrect level is present of in a indistinct way in the superior part of the box (left, right) and in the bottom (left, right). See figure 3.

This incident appeared irregularly between August and October.

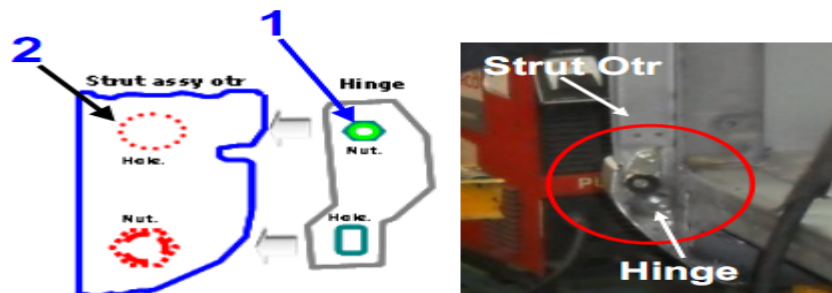
Figure 10. Mounting operation (Source SIICA)

In the assembly operation of RR Gate placement is made hinge LH / RH to Strut Assy Otr. The Hinge is the mechanism that allows movement to RR Gate once fixed on the side and the Strut Assy tr., is support for fixing the Hinge. To fix it matches the nut of the hinge (1) through hole of the strut assy otr. (2) and to guide the bolt rope 3 minimum and vice versa. See Figure 10 to understand what is written.

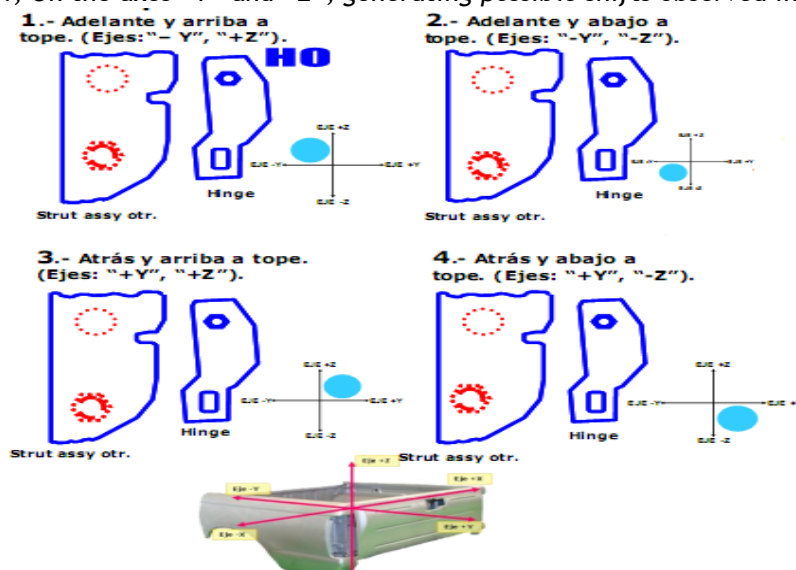
Figure 11. Possible displacements, Source SIICA

Once determined the assembly, it was observed that the hinge presents displacement (set) in the strut assy otr., On the axes "Y" and "Z", generating possible shifts observed in Figure 11.

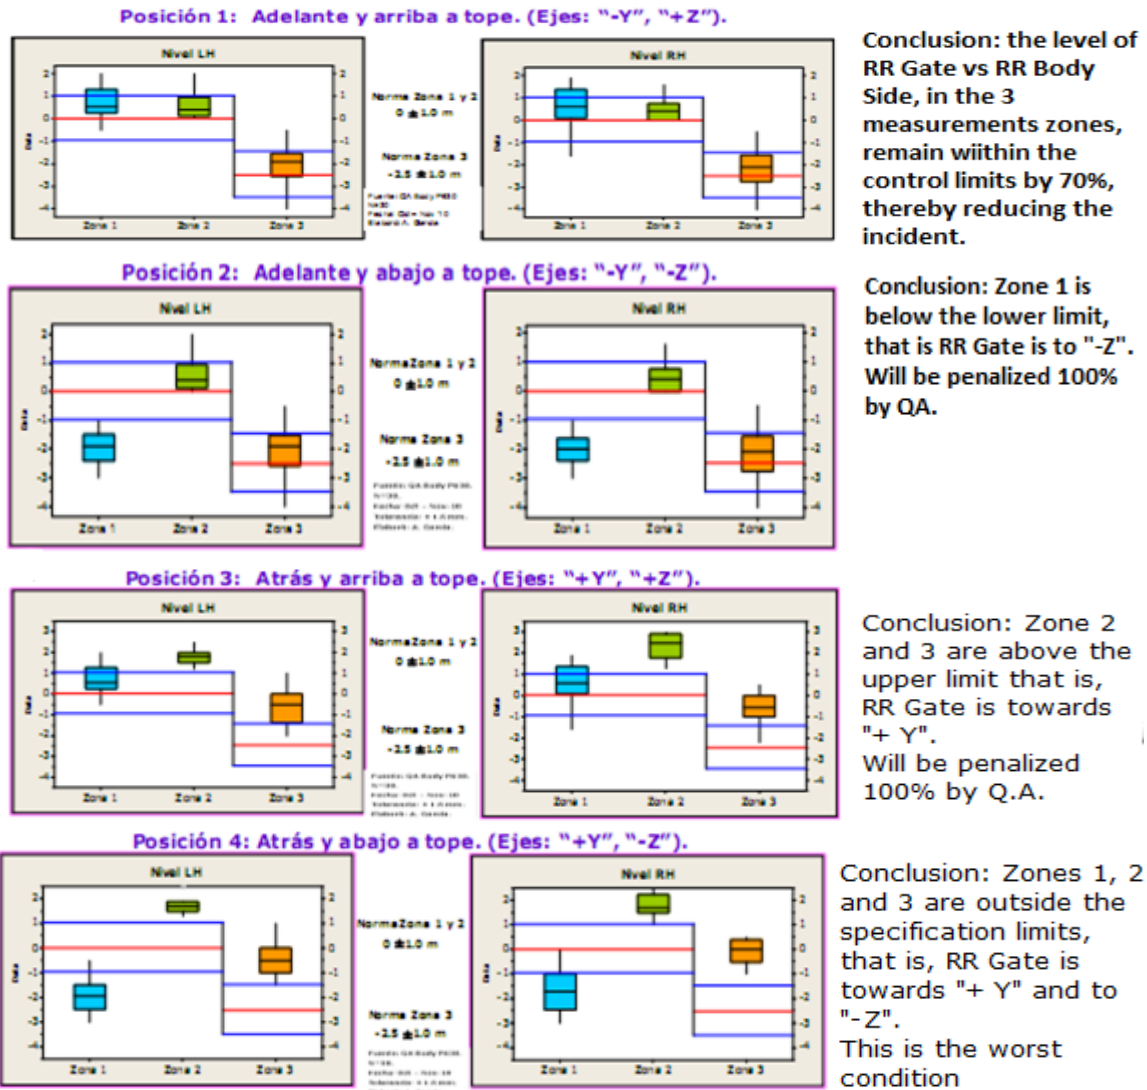
Figure 12. Box Plot Nivel RR Gate vs RR Body Side (Source SIICA)

It was found that the 1 (OH) does not guarantee 100% assembly and the remaining 3 positions definitely generate the incident, with these results it was concluded that the fixing position of the hinge to the Strut assy otr., is the potential factor of the problem (lack of concentricity between the Nut of Hinge and Strut Hole of Otr. (Figure 13)

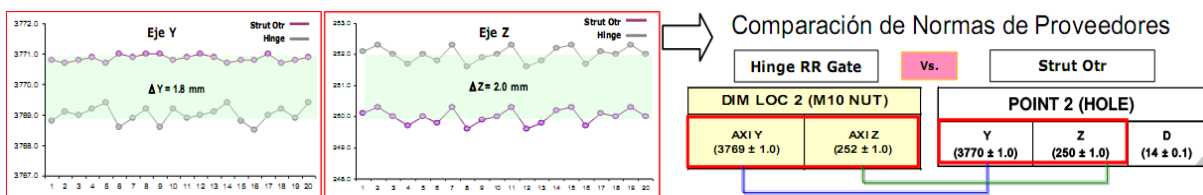
Figure 14. Comparative Data

Comparativo de datos de reportes Proveedor (Diferencias):  
 Eje Y (Promedio)= 1.8 mm; Eje Z (Promedio)= 2mm

Existe diferencia entre normas en eje "Y" de 1 mm. y en "Z" de 2 mm.

Reports comparing dimensional parts suppliers involved, there was a difference between standards with which they had in the company.

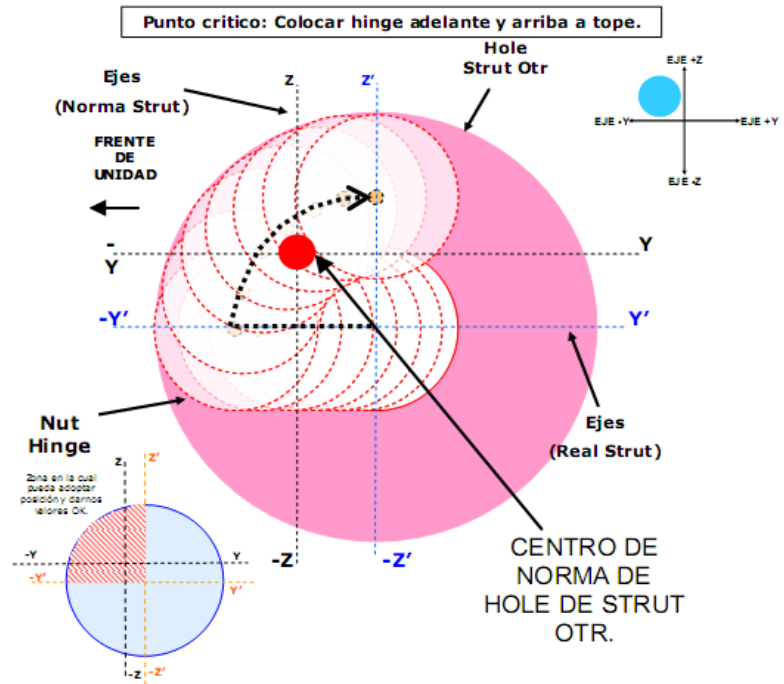
Figure 15. Location of the hinge nut, source SIICA

There is a difference vs. the design view in the standard of the center of the Strut Hole Otr. There is a marked shift in the norm of the center of the Strut Hole Otr., In the Y and Z, which causes the loss of concentricity between the parties. In making the motion simulation indicating HO following was observed (Figure 15).

By respecting the method, on the Y axis (forward), the position of the hinge nut is outside the center of the standard, however, to move in Z axis (upper limit), at some point this position is very close the center of the standard (due to displacement of the nut bolt for fixing the hinge on the strut hole circle Otr.)

The location of the hinge nut non-standard (sending) in the hole of the strut otr., Is the root cause of the problem.

CAUSA RAIZ	¿Qué? (What)	¿Por qué? (Why)	¿Cómo? (How)	¿Dónde? (Where)	¿Quién? (Who)	¿Cuándo? (When)	¿Cuánto? (How much?)
<b>La localización del Nut del Hinge fuera de norma (centro de origen) en el Strut Otr</b>	Fabricación de Plantilla	Para garantía de localización de Hinge en Strut Otr a norma	De acuerdo a dibujo NM-PC-016-D22 emitido por Procesos Carrocerías	Taller de herramental (Mantenimiento pl-2)	Pedro Pedroza Personal Herramental PI-2	7 al 11 Diciembre 2010	Eliminar al 100 % incidente de nivel incorrecto (en las 3 zonas del RR Gate vs. RR Body Side) desde origen
<b>La falta de establecimiento de la frecuencia de limpieza fuera de norma de los dispositivos sujetadores</b>	Realizar limpieza al 100 % de los dispositivos sujetadores	Para garantizar la funcionalidad del dispositivo sujetador	De acuerdo a H.O. Limpieza de soportería "CM-D22-02"	Taller de proveedor	Sergio García Ing. Procesos Pintura	11 y 12 Diciembre 2010	Eliminar la posibilidad de que la zona 2 del incidente, presente nivel incorrecto, esto por deformación del RR Gate en el proceso de pintura

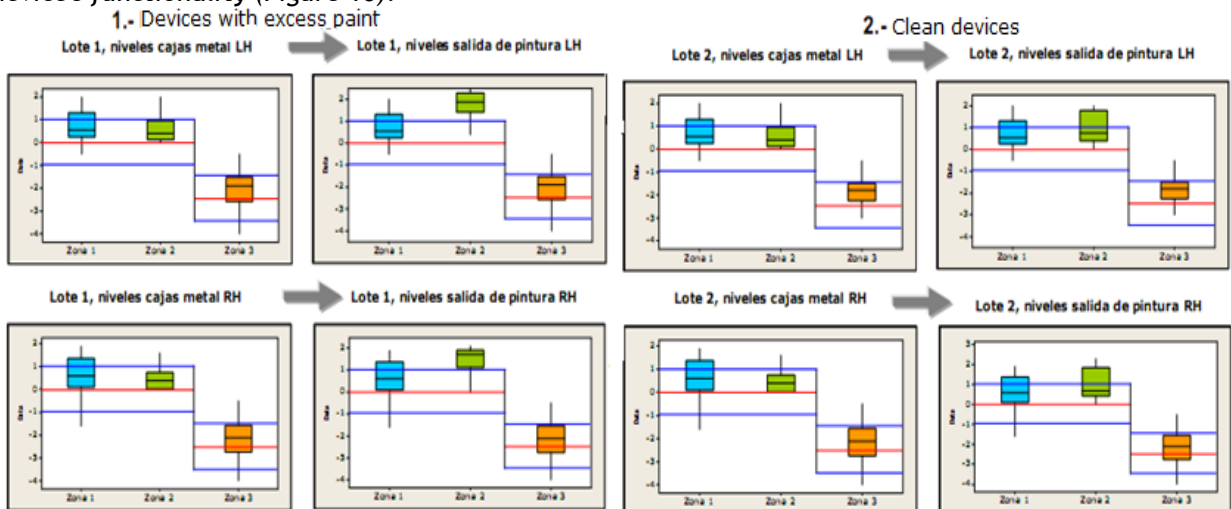
Figure 16. Box-plot of devices, source SIICA.

So we proceeded to verify whether the excess paint was the cause of the problem. Were conducted test with cleaned devices and with excess paint respecting the operation sheet and analysis was made with measurements obtained by box plots and it was detected that painting in the device was above the allowed limit and the gate undergoes a slight deformation failure due to lack of device's functionality (Figure 16).

Standard zone 1 and 2:  $0 \pm 1.0 \text{ m}$ ; Standard zone 3:  $-2.5 \pm 1.0 \text{ m}$

In both lots in Zones 1 and 3 do not vary, but in zone 2 is above the upper limit of what causes the RR Gate suffers a deformation in the painting process, we conclude that the excess paint in the means for fastening is a potential factor.

Modificar la frecuencia de limpieza a 20 días	Para garantizar la funcionalidad del dispositivo sujetador	De acuerdo a H.O. Limpieza de soportería "CM-D22-02"	Oficina de Manufactura	Sergio García Ing. Procesos Pintura	15-Dic-10	
	Elaboración y establecimiento de "GO NO GO"	Para garantía de funcionalidad de dispositivos sujetadores	De acuerdo a dibujo NM-PC-017-D22 y H.O. FIX RR GATE emitido por Procesos Carrocerías	Oficina de Manufactura Taller Central	Antonio García Ing. Procesos Carrocerías Antonio Sánchez Ing. Taller Central	15 y 16 Diciembre 2010

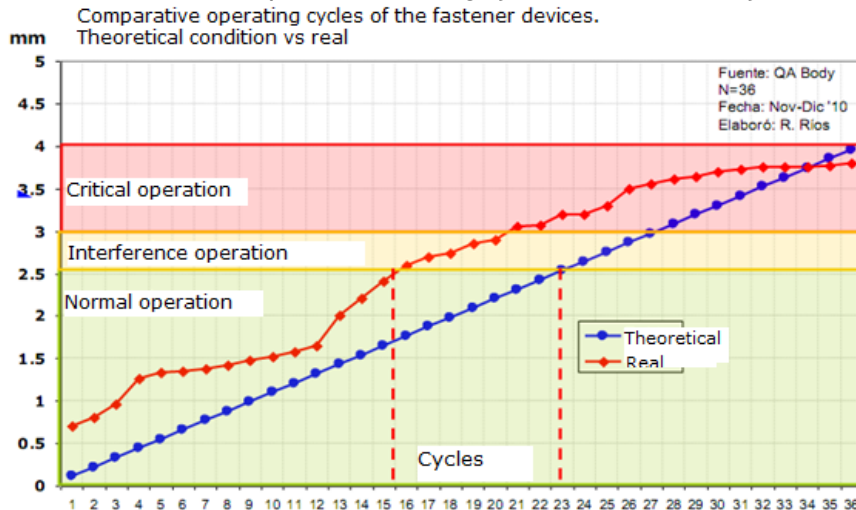
Table 3. Comparative cleaning cycles, source QA Body

In real conditions the devices begin to lose functionality between cycles 15 and 23, was theoretically between 23 and 27 cycles. Looking at the painting process devices, circulating on average 12 cycles per month. The supplier makes move 24 cycles (critical condition) that was defined for them while cleaning, which is set in the method but not defined the period for doing so.

There are the rules but do not set the cleaning period and the lack of establishment of the specific frequency of cleaning means for fastening was the root cause of the problem.
