¹Kofi AGYEKUM, ²Burcu SALGIN

DIAGNOSING RISING DAMP IN RESIDENTIAL BUILDINGS: LESSONS FROM THREE CASES

¹Department of Building Technology, Kwame Nkrumah University of Science and Technology, Kumasi, GHANA

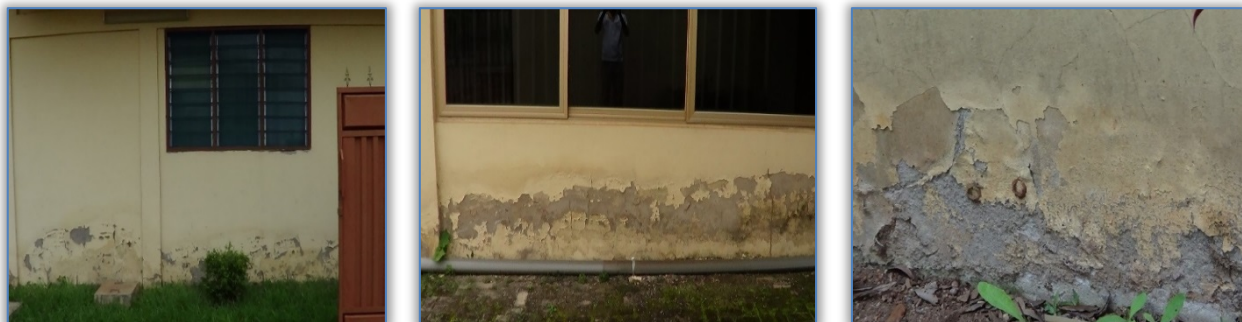
In Case Study 1 the visual inspection carried out on the building led to the identification of damp patches all around the bases of the external walls. Apparently, the internal walls were quite healthy and showed no symptoms or signs of dampness. Moisture contents recorded from the internal wall finishes and skirting were less than 1.0% indicating that they were dry. No stains or signs of deterioration were found on the internal wall faces. However, on the external faces of the walls, high readings, some up to about 2.4% were recorded from the moisture meter. Symptoms such as blistering of paints, flaking of mortar, surface efflorescence, and damp patches in horizontal bands were identified on all the external walls in Case 1 (Figure 3a).

Figure 3a. Some symptoms of dampness identified from the building in Case 1 (Source: [22])

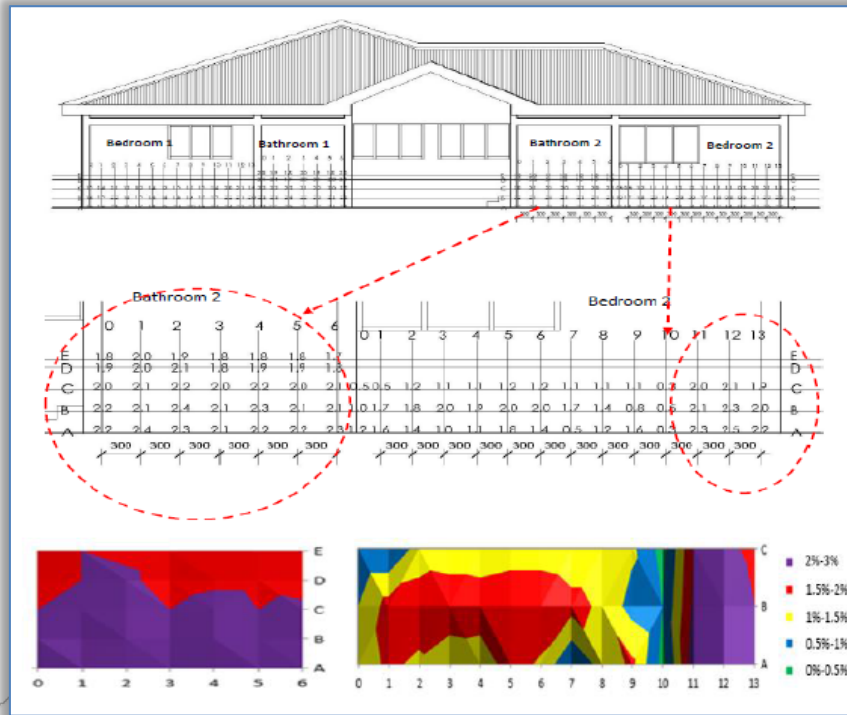
The moisture meter was used to measure moisture contents in the walls of all the four orientations (eastern, western, northern and southern) of the building in Case 1. The moisture measurement showed that all the walls were affected by dampness. However, the walls in the western orientation recorded the highest moisture contents as leakages from defective plumbing works combined with other sources of moisture. The moisture contents recorded on the walls of the two bathrooms within Case 1 were very high and reached heights of 1.2 m (Figure 3b). This is very unusual as dampness on the walls of the other rooms reached maximum heights of 600 mm.

Figure 3b. Measured moisture contents on the walls shown in contour maps (Source: [22])

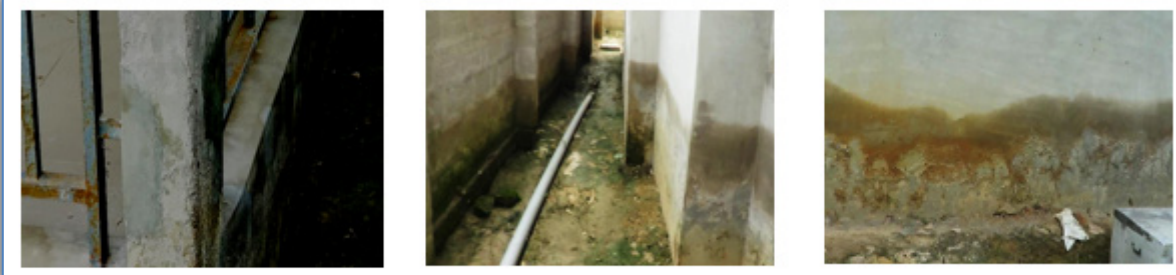
Figure 4a. Some symptoms of dampness identified from the building in Case 2 (Source: [23])

In Case 2 the site inspection carried out on the building also led to the identification of several symptoms. These symptoms included cracks in columns probably due to salt attacks, greenish stains on walls, blistering of paint, brownish yellow stains on walls, flaking of mortar, etc. (Figure 4a). Results from the moisture content measurements on the external walls of the building in Case 2 further showed that the walls in the eastern orientation were severely affected by dampness. These damp zones are indicated in purple color in the contour map shown in Figure 4b. Though there existed low level of dampness on some of the grids (for instance A8), dampness recorded in majority of the zones were between 1.5% and 2%, an indication of the severity of the problem. This orientation of the wall was very close to a river which served as a source of water ingress into the walls of the building. For the building in Case 3, the site inspection revealed symptoms similar to those in Cases 1 and 2. Symptoms of dampness were identified on the external walls of all the four orientations and were very severe in the walls of the washrooms and the adjoining bedrooms. Blistering of paint, flaking of plaster and surface efflorescence were evident on most of the external and internal wall surfaces (Figure 5a). Dampness was evident in all the walls but was very pronounced in the walls located in the western orientation, rising to a maximum height of 1200 mm.

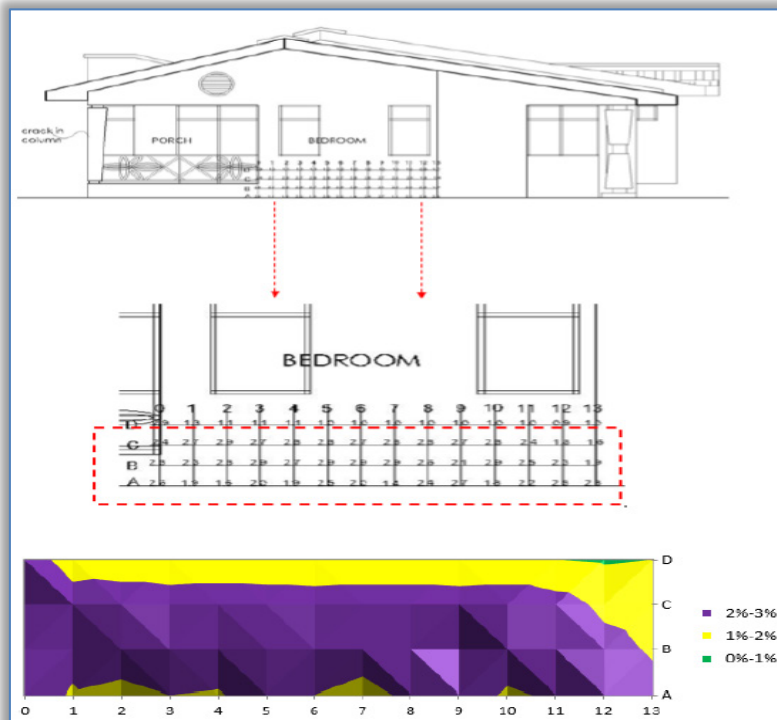
Figure 4b. Measured moisture contents on the walls shown in contour maps (Source: [23])

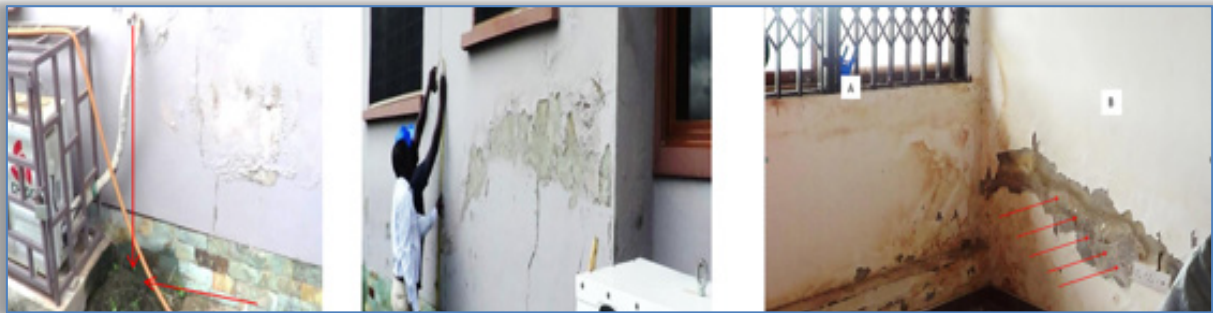
Figure 5a. Some symptoms of dampness identified from the building in Case 3 (Source: [24])

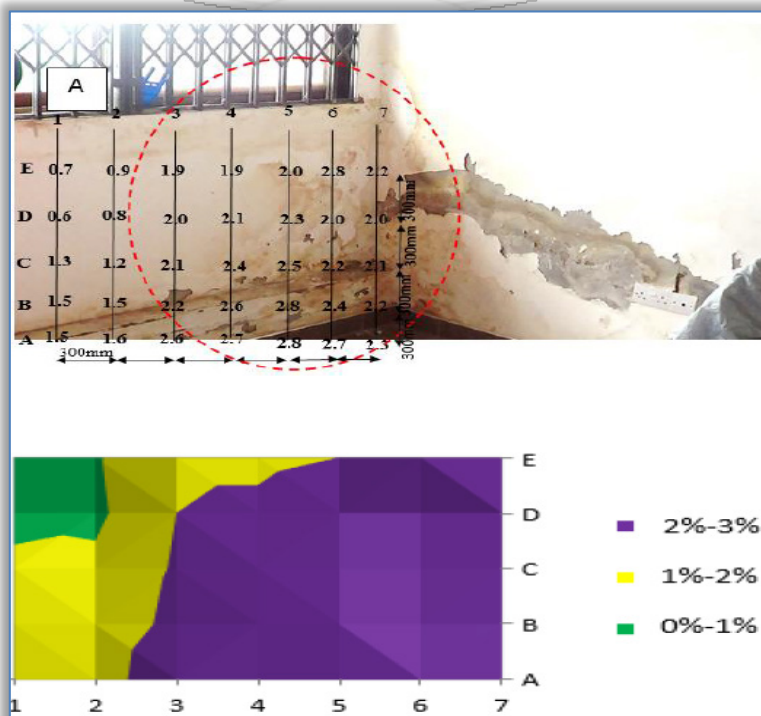
The distribution of moisture contents along and across the faces of the severely affected walls of the building in Case 3 showed that the internal walls of the bedroom oriented in the western direction were severely affected by dampness. The severity of the problem was due to combinations of moisture from sources such as the ground and defective plumbing works in the bathrooms. The severely affected zones in Figure 5b is shaded in the purple color. In these zones, all the moisture contents recorded on the walls ranged from 1.5% and above. This indicates that dampness was very severe and further studies should be conducted in these areas.

Figure 5b. Measured moisture contents on the internal walls shown in a contour map (Source: [24])

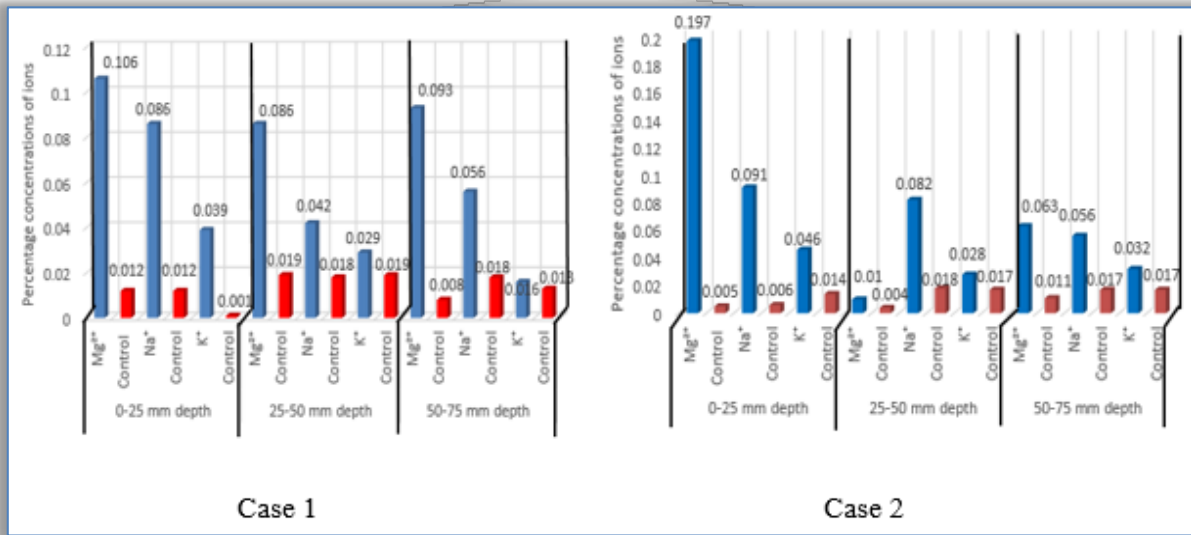
The results showed that at the maximum height of visible dampness (i.e. 900 mm), magnesium (Mg^{2+}) is the most predominant cation in the mortar samples collected from Cases 1 and 2 followed by sodium (Na^+) and potassium (K^+) in that order. Percentage concentrations of these ions exceed the acceptable safe limit of 0.020% [16, 18, 20] and the concentrations decreased with increasing depth.

Figure 6a. Comparison of ionic concentrations of most predominant cations from Case 1 and Case 2 at heights of 900 mm for different depths.

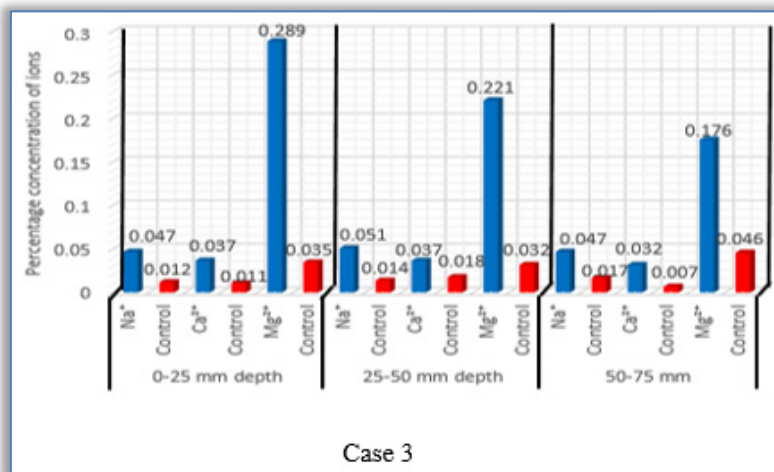
Figure 6b. Comparison of ionic concentrations of most predominant cations from Case 3 at heights of 1.2m for different depths

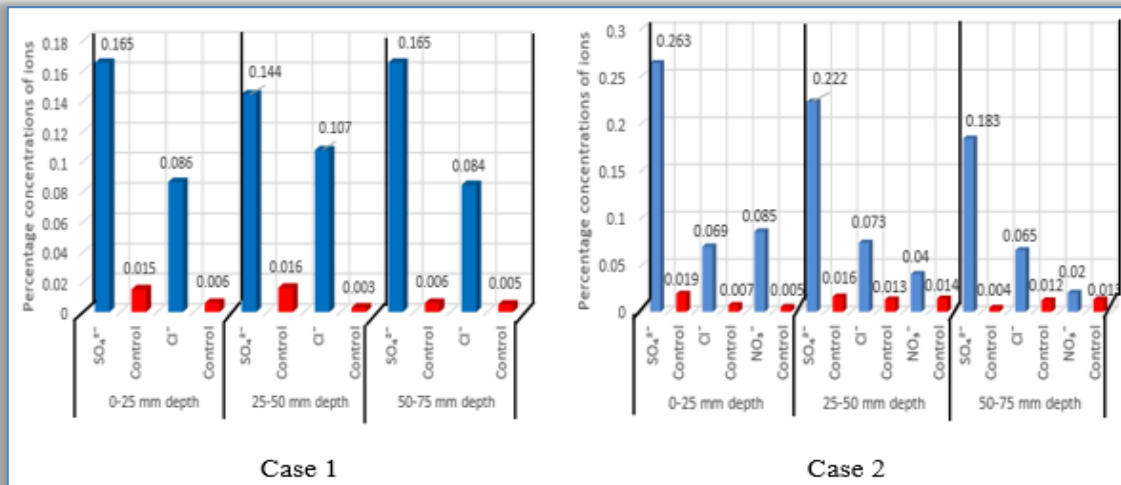
Figure 7a. Comparison of ionic concentrations of most predominant anions from Case 1 and Case 2 at heights of 900 mm for different depths.

The results further show that the anions, sulphate (SO_4^{2-}) and chlorides (Cl^-) were also predominant at the maximum heights of 900 mm for the buildings in Cases 1 and 2. Similarly in Case 3, the most predominant anions identified at the maximum height of visible dampness were SO_4^{2-} and Cl^- , with nitrates (NO_3^-) in smaller quantities.

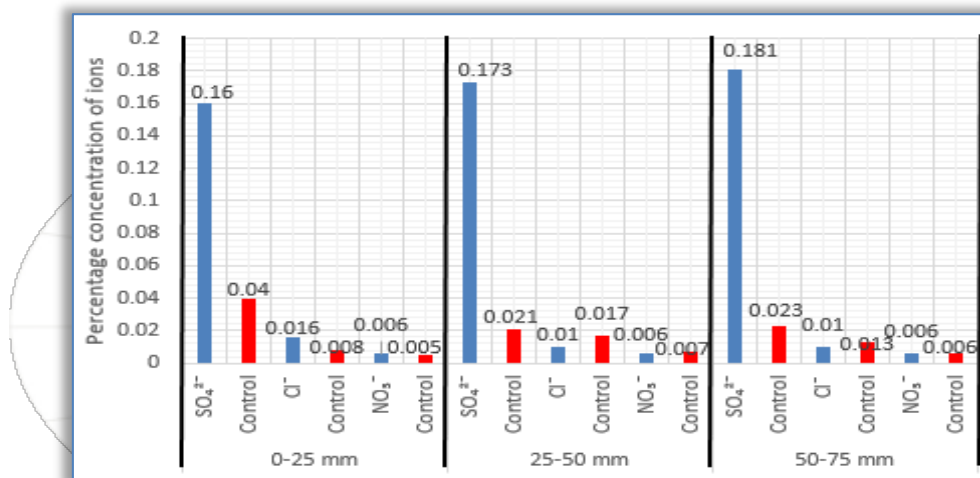
For the samples collected from Case 3, the results (Figure 7b) show that at the maximum height of visible dampness (1200 mm), Mg^{2+} is the most predominant in the mortar samples collected, followed by Na^+ and Ca^{2+} in that order. Percentage concentrations of these ions exceed the acceptable safe limit of 0.020% [16, 18, 20].

Figure 7b. Comparison of ionic concentrations of most predominant anions from Case 3 at heights of 1.2 m for different depths.
