1. Vujadin ALEKSIĆ, 2. Dejan MOMČILOVIĆ,
3. Bojana ALEKSIĆ, 4. Ljubica MILOVIĆ, 5. Aleksandar SEDMAK

ANALYSIS OF THE STEAM LINE DAMAGES

1-2. IWE, IMS Institute, Belgrade, SERBIA

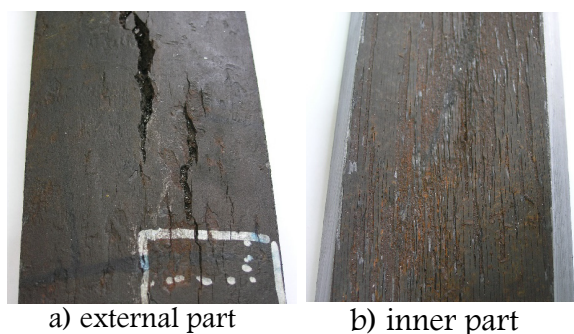
The structure of the steam line is exposed to the low-cycle fatigue loads. Such a load caused fatigue fracture and leakage of the steam line for live steam at RA 10, TPP Kolubara A, Table 1, which was determined by visual examination, Figure 1.

a) external part b) inner part
Figure 1. The Appearance of the damaged part

The cause of leakage is the inhomogeneity of the material and a greater number of hours in operation than prescribed, and the result is creep of the base metal, leakage and failure of the steam line.

In order to prevent such phenomena, it is necessary to have a system of preventive maintenance and keep accurate records of all actions on the steam line, as well as to keep records on the quality of the materials built-in at the beginning and during exploitation of the steam line, respecting the terms of regular and emergency inspection prescribed by the Regulations.

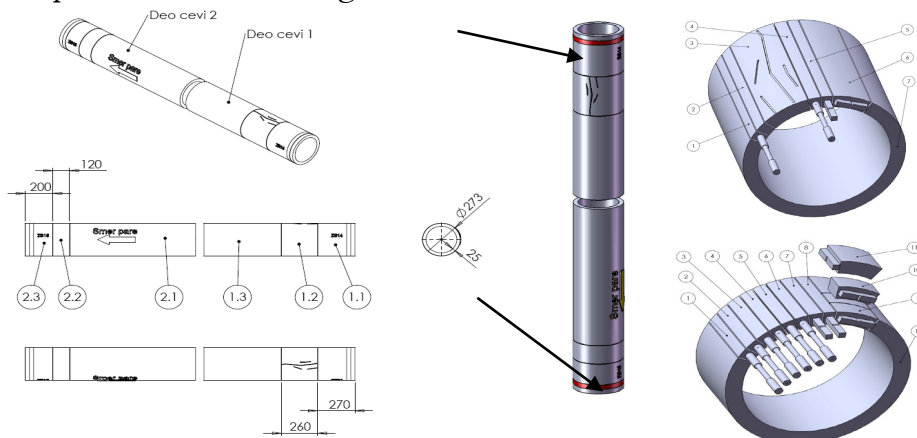
Figure 2. Positions of Annular Segments and Test Specimens

In order to analyze the damage and determine the cause of leakage of the steam line for live steam, line RA 10, TFP Kolubara A, two parts of the pipe Ø 273x25 mm, sampled from the same pipe of the leaking steam line, were submitted for examination. Namely, the pipe part with damage 1080 mm-long (1) and the pipe part without damage approx. 1260 mm-long (2), Figure 2, were submitted. From the pipe samples submitted the specimens and raw parts were made for testing, sampled from the positions defined in Figure 2.

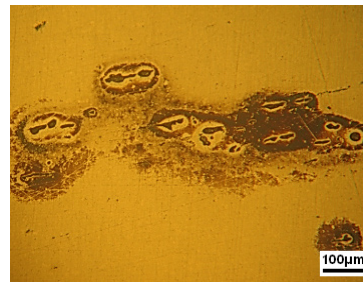
In the microstructures of tested replicas taken from the surface of the material of the damaged pipe a certain degree of quality degradation was observed, induced by the initial spheroidization and precipitation of carbides at the grain boundaries, with presence of scattered globular perlite - level of qualitative degradation of the microstructure B/C. [2]. The assessment of microstructure of the

a) Sample 1.2.3 (without etching), longitudinal section, coarse non-metallic inclusions of A3, B1 and D2 type.

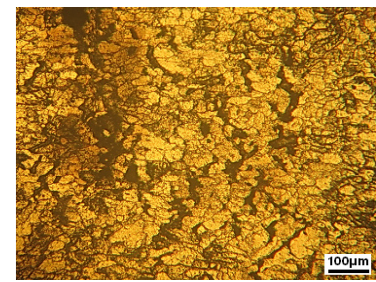
b) Sample 1.2.3 (3%/-nital etched), transversal section, propagation of one of the macro cracks inside the pipe material

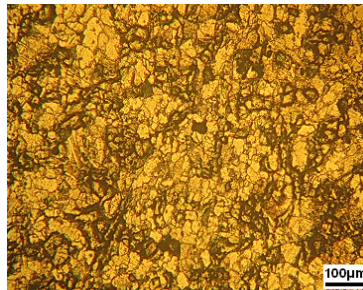
c) Pipe sample 1.2.6 (3%/-nital etched), transversal section, predominantly ferritic microstructure in the pipe cross section

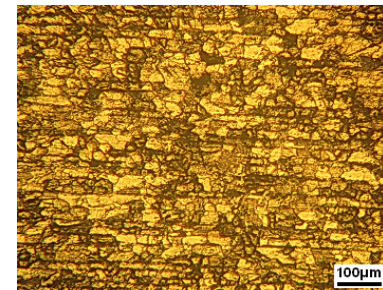
d) Pipe sample 2.2.9 (3%/-nital etched), longitudinal section, predominantly ferritic, finely stripped microstructure in longitudinal section of the pipe.
