<sup>1</sup>. Mardziah KHALID, <sup>2</sup>. Md Azree Othuman MYDIN

## BUILDING CONDITION ASSESSMENT AND DEFECT ANALYSIS ON HERITAGE SHOPHOUSES IN PENANG, MALAYSIA: CASE STUDIES

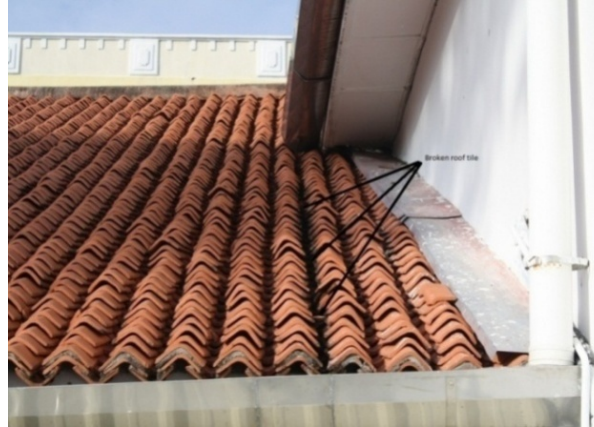
Figure 1: Slippery and broken roof at GTWHI building

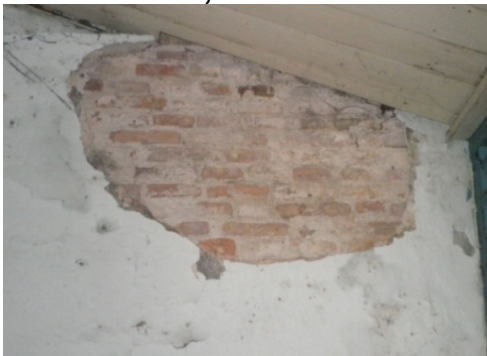
(i) Loose plasterwork of brickwork

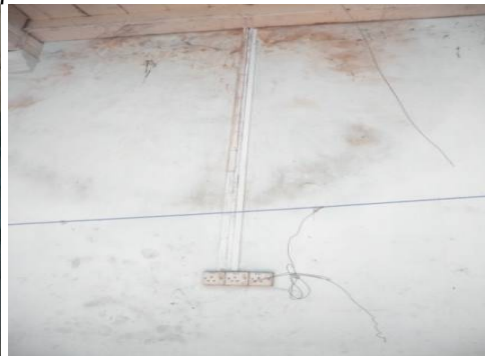
(ii) Water staining on wall

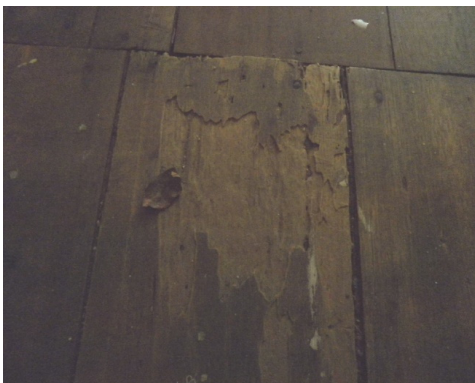
Figure 4: Termite attack can be seen on timber planks at the first floor

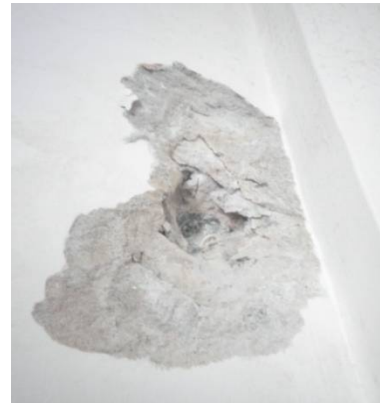
Figure 3: Plaster loose near to the store area at GTWHI building

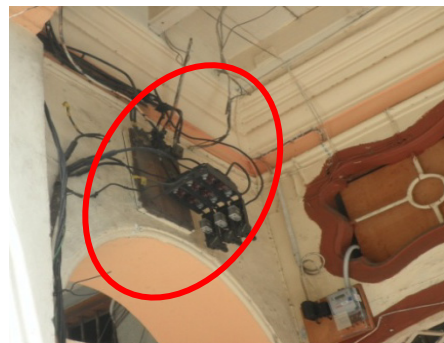
there is no adequate cover to place the electricity wires and others. The electricity wires need to put in a box or something that can protect the material inside the meter unit. From Figure 7, it can be seen that the electricity wire look messy and harmful to everyone.

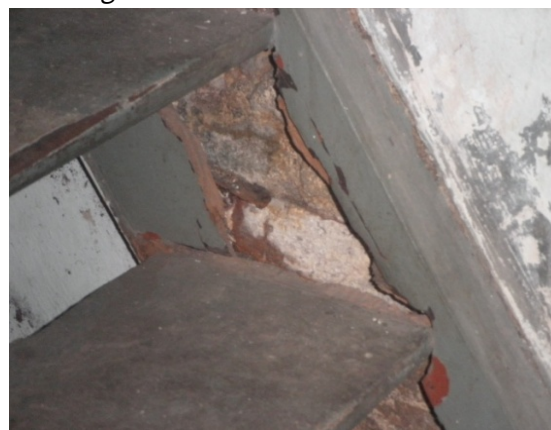
Figure 5: Timber decay appeared on the handrails of staircase

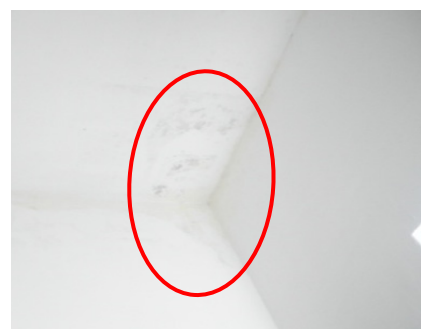
Figure 6: Water staining on ceilings
