## **EXPERIMENTAL INVESTIGATIONS ON THE MUSTAFA PASHA MOSQUE LARGE SCALE MODEL**

The experimental results presented in this paper are a part of the activities performed within the Sixth Framework Program PROHITECH - "Earthquake Protection of Historical Buildings by Reversible Mixed Technologies". For the selected prototype structure - historical monument Mustafa Pasha Mosque in Skopje, a 1/6-scale model was constructed and tested on seismic shaking table in several phases. The objective of the experimental model testing was to investigate the seismic stability of the monument after applying a reversible strengthening technology. It was concluded that the behaviour of the strengthened model was evidently different from that of the original model.

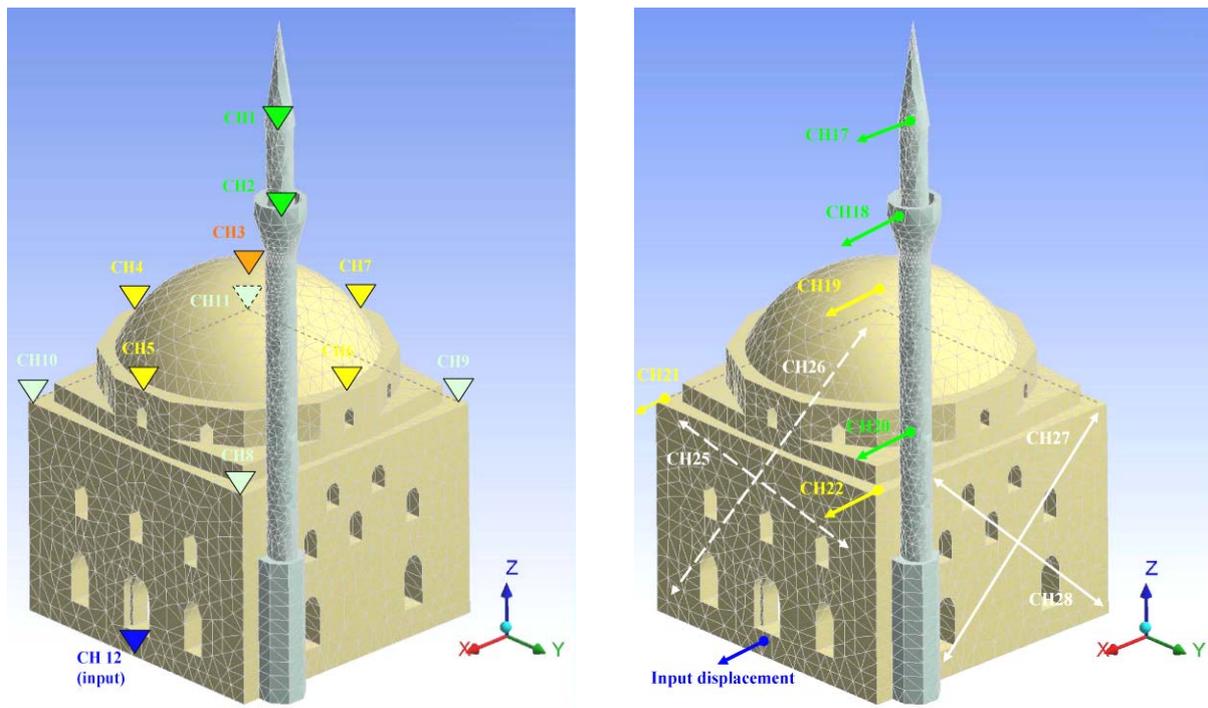
**Figure 1.** Instrumentation of the mosque model with accelerometers and displacement transducers

To investigate the model's response during seismic action, different types of transducers were placed at characteristic points - accelerometers, linear potentiometers and LVDTs, as presented in Fig.1.

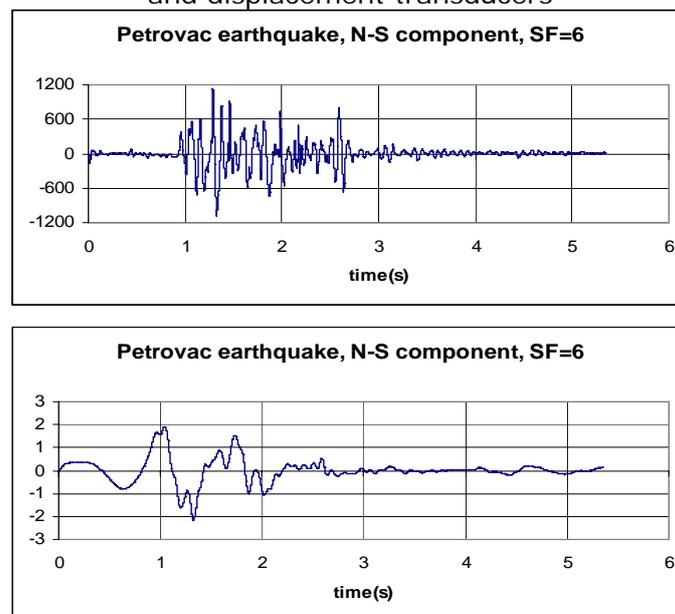
**Figure 2.** Time histories of acceleration and displacement, earthquake excitation Petrovac, N-S component

Before starting the seismic testing, the dynamic characteristics of the model were defined by means of ambient vibration method as well as by low intensity random excitation within the frequency range of 0.1-50 Hz [1]. The accelerogram of the Montenegro earthquake of 1979 (Petrovac N-S component) was selected as a representative earthquake excitation. The acceleration and displacement time histories of the input excitation are given on Fig. 2.

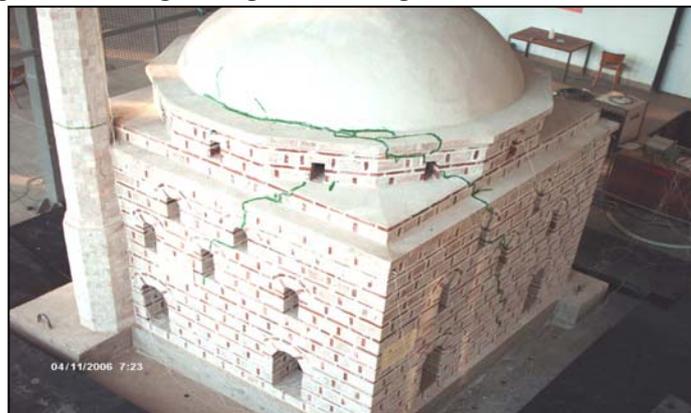
**Figure 3.** Damage to the minaret (horizontal crack) and the mosque after phase 1

The earthquake time histories were scaled (compressed) 6 times, according to the similitude requirements and several tests were performed with intensity of 0.01- 0.10g. Under input intensity of 2%g, the first horizontal crack appeared at the base of the minaret. In the next tests performed under intensities of up to 10%g, damage occurred on the mosque, too. The reason of this was the frequency content of the applied excitation, which was close to the natural frequencies of both the minaret and the mosque. The damaged model is presented in Fig. 3, while some representative response parameters for input intensities of 2%g and 10%g are given in Fig. 4.

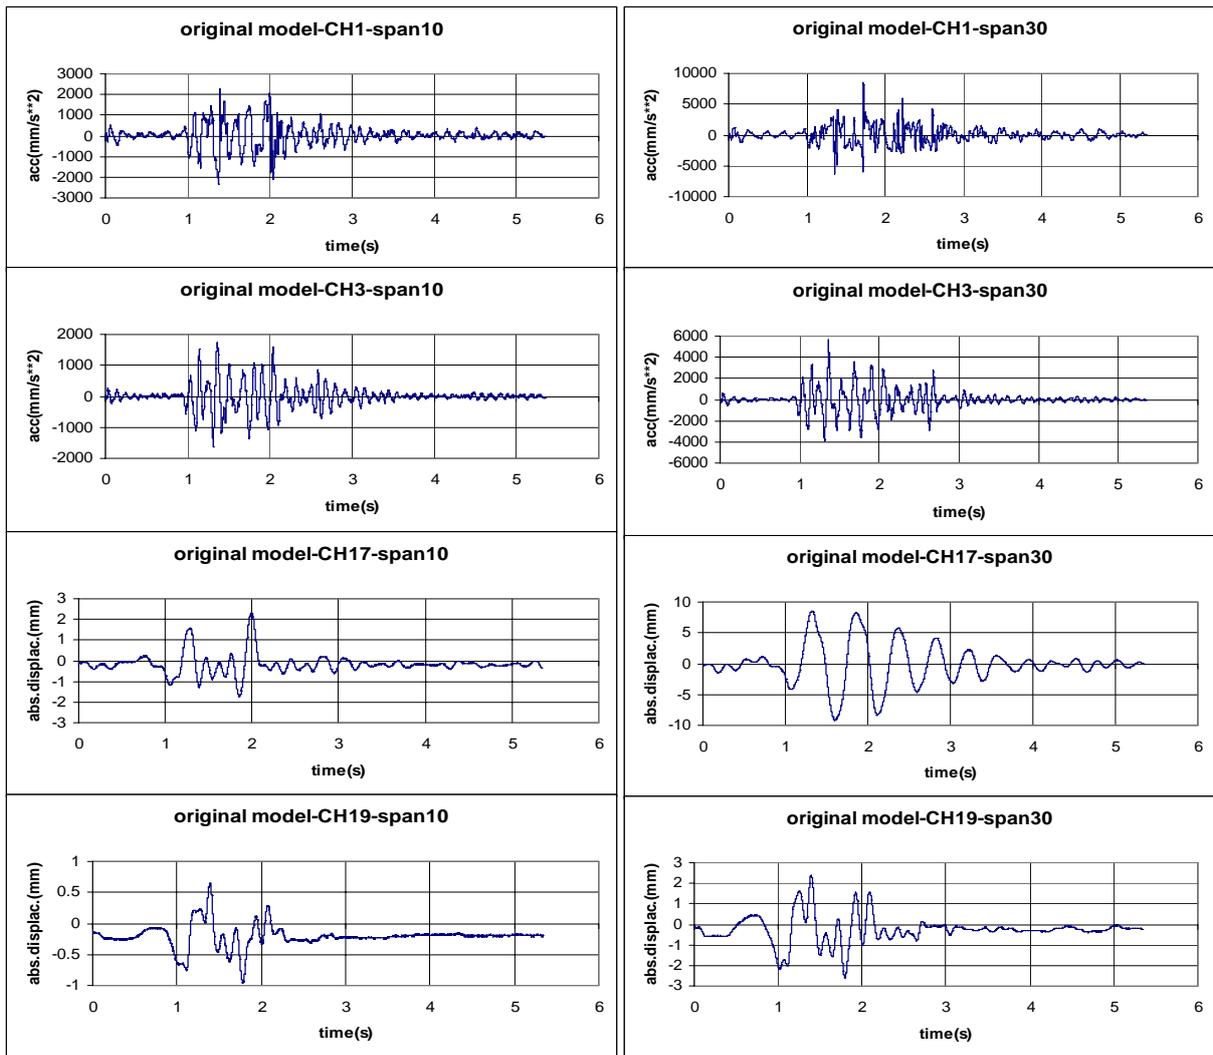
**Figure 4.** Characteristic response time histories under input intensity of 2%g (left) and under input intensity of 10%g (right), original model

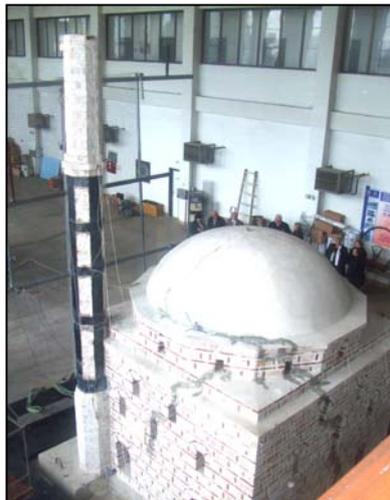
**Figure 5.** Repaired model and strengthened minaret after phase 1 testing

After performing the seismic tests on the original model of the mosque, the damaged model was repaired by crack injection and the minaret was strengthened by application of CFRP wrap [2], cut to have the corresponding width and applied upon a layer of epoxy glue, Fig. 5. The obtained strips with a width of 15 cm were placed on four sides along the length of the minaret in vertical direction for the purpose of its stiffening. To confine the structure, strips with a width of 10 cm were placed at four levels along the height of the minaret in horizontal direction, while a strip with a width of 20 cm was placed at its base.

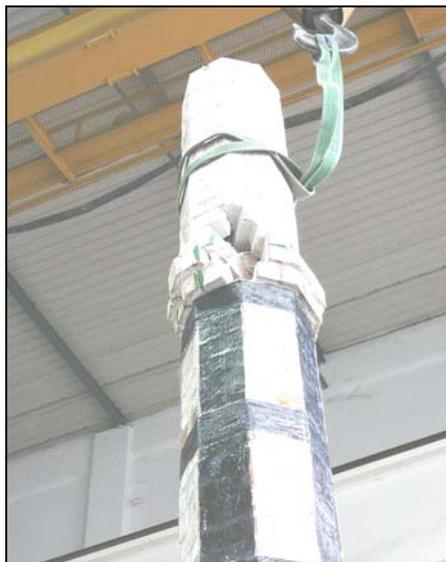
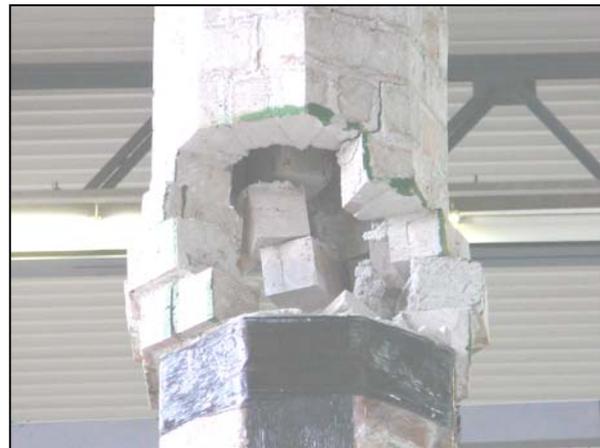
**Figure 6.** Collapse of the upper part of the minaret

The initial cracks in the mosque appeared under input intensity 0.42g. During the next tests, the cracks developed and at input level of 0.49g, the upper part of the minaret totally collapsed, Fig. 6. After reaching the max input

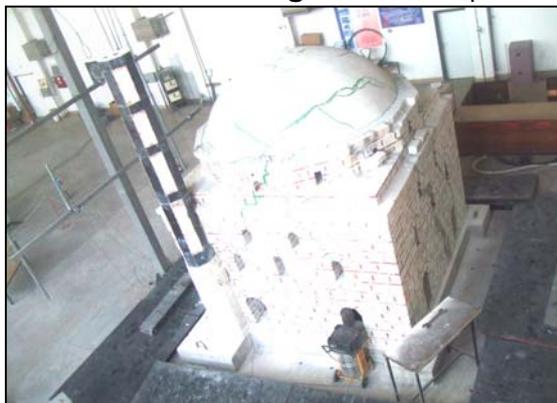
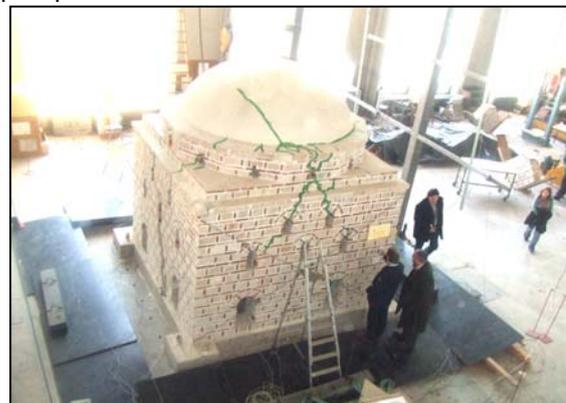
**Figure 7.** Damaged model after phase 2 testing

acceleration of 1.5g, the mosque model was heavily damaged and the testing was stopped. There were cracks in the walls and also in the dome. Some details of the damage are presented on the photos displayed in Figs. 7 and 8. The characteristic response parameters during the seismic tests are given in Table 1, while the representative time histories for the test with intensity of 0.34g and for the final test with an input intensity of 1.5g are given in Figs. 9 and 10, respectively.

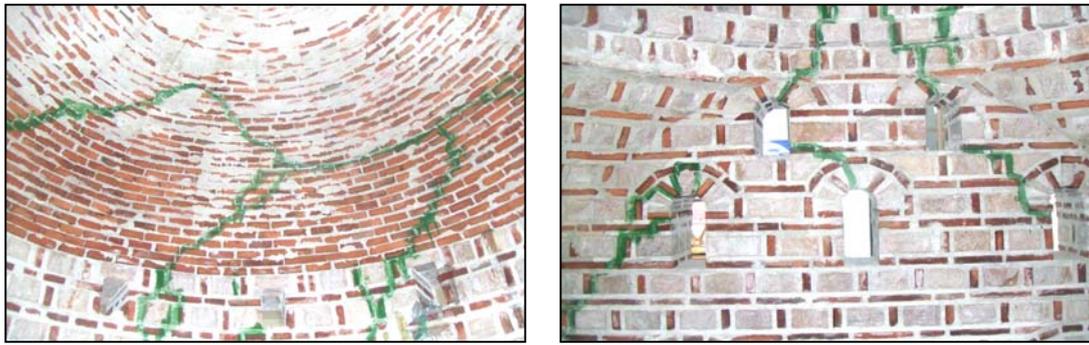
Figure 8. Damage of the mosque, interior

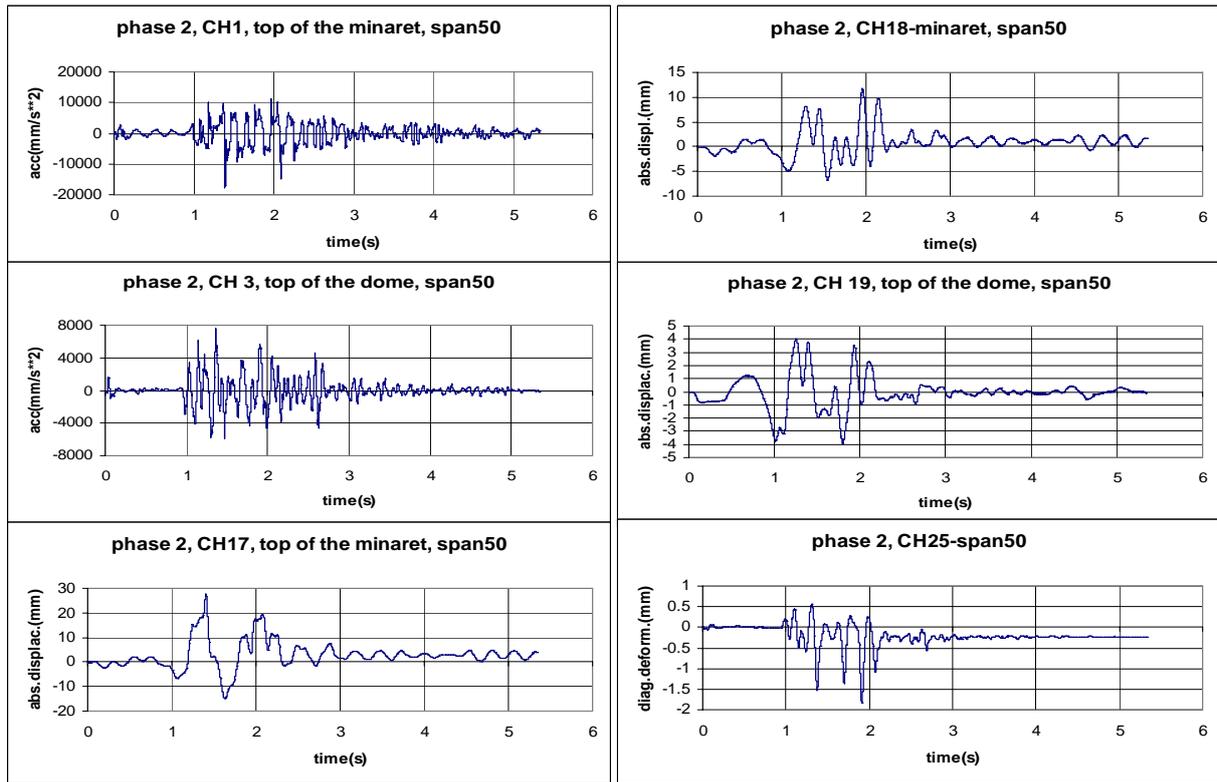
Figure 9. Characteristic response time histories for input intensity 34%g, phase 2

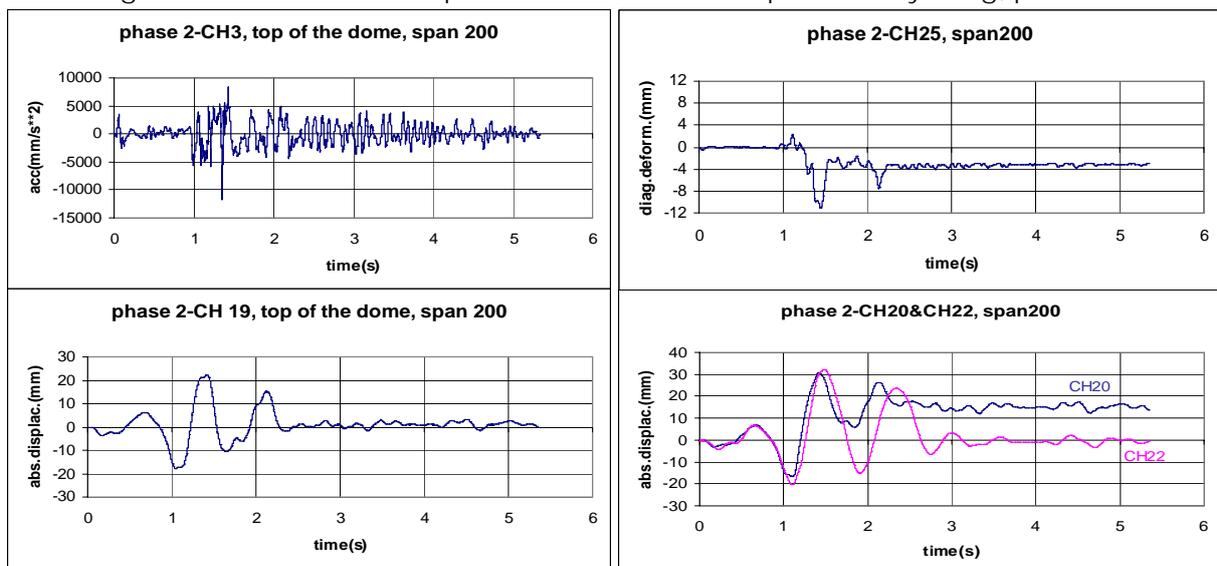
Figure 10. Response during the test with intensity 1.5g, phase 2

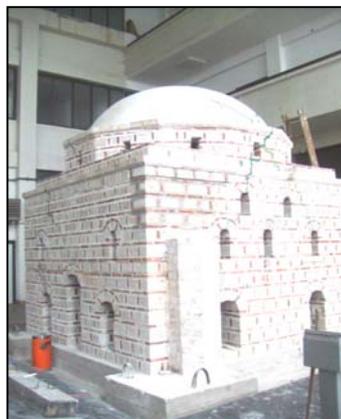
**Figure 11.** Re-built part of the model after removal of the minaret

After the final test of the model in phase 2, the minaret was removed and the damaged parts of the mosque were rebuilt, Fig. 11. Then the model was strengthened [3]. The main adopted principle in strengthening of the model was that the methodology to be applied be reversible and invisible. Hence, the cracks in the damaged model were not repaired by injection, but a concept was adopted that the model be strengthened to the conditions after the preceding tests.

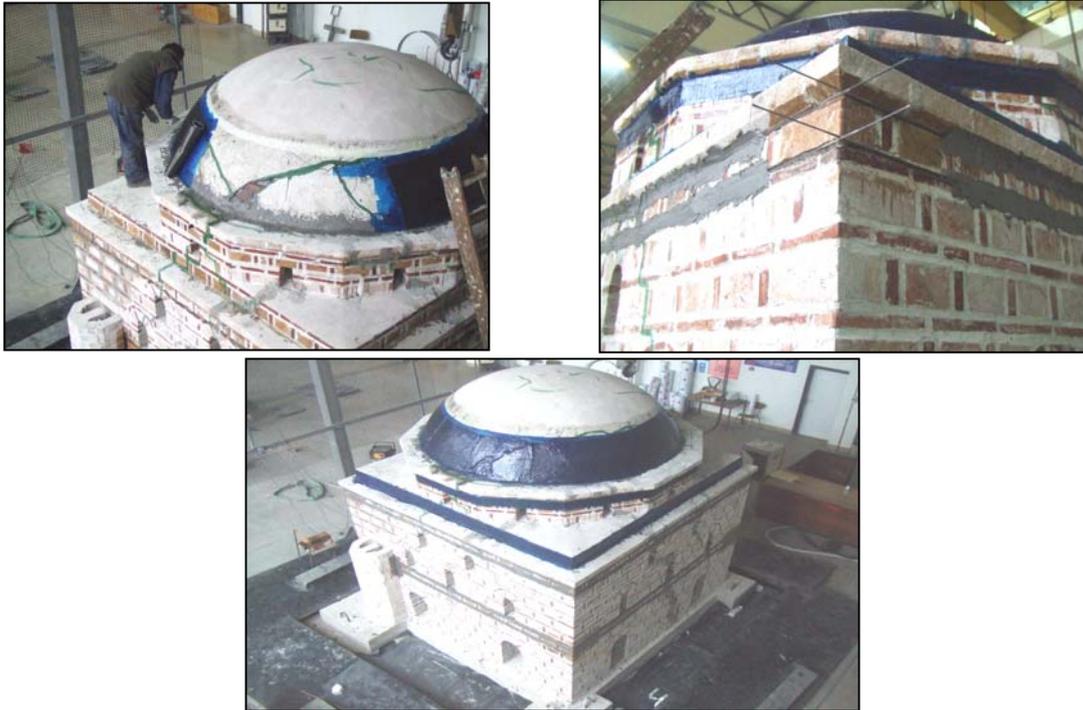
**Figure 12.** Details of strengthening and strengthened model ready for testing, phase 3

- Incorporation of carbon rods in two longitudinal mortar joints around the four walls at two levels: the level above the openings and at the top of the bearing walls, immediately below the tambour. For that purpose, the mortar in the joints was first of all grooved down to the depth of 1.5 to 2 cm and such an obtained surface was fixed by a corresponding material (primer). After curing, longitudinal carbon rods were placed in the joints of each facade of the bearing walls. At both ends, these rods were cantilevered for about 25 cm in order that they could cautiously be bent and attached to the rods of the adjacent walls. Then the grooved part of the joint was filled with epoxy resin. To strengthen the corners where the carbon rods are bent and have a lower bearing capacity, a carbon strip with a length of 25 cm was placed upon the resin. With the incorporation of these carbon rods, a horizontal belt course was formed whereby the tensile resistance of the wall was improved and synchronous behaviour of the bearing walls was achieved.

- Formation of a horizontal belt course around the tambour by applying a CFRP wrap with a width of 10 cm. After the application and the drying of the layer used for fixation of the masonry (primer), a thicker layer of epoxy glue (~3-4 mm) was applied for gluing the CFRP wrap upon it. To impregnate the strip, it was cautiously glued to the lower layer of resin by means of rollers. Finally, another layer of epoxy glue was applied and the entire surface was treated with the roller again.

- Formation of a horizontal belt course at the base of the dome by use of a CFRP wrap. The procedure for the formation of this belt course was identical to that used for the tambour except that the wrap had a width of 50 cm.

The formation of these horizontal belt courses enabled better integrity of the tambour and the dome base and prevented "opening" of the dome which was the most common reason for occurrence and prolongation of cracks in the bearing walls. The strengthened model and some details of strengthening are presented in Fig. 12.

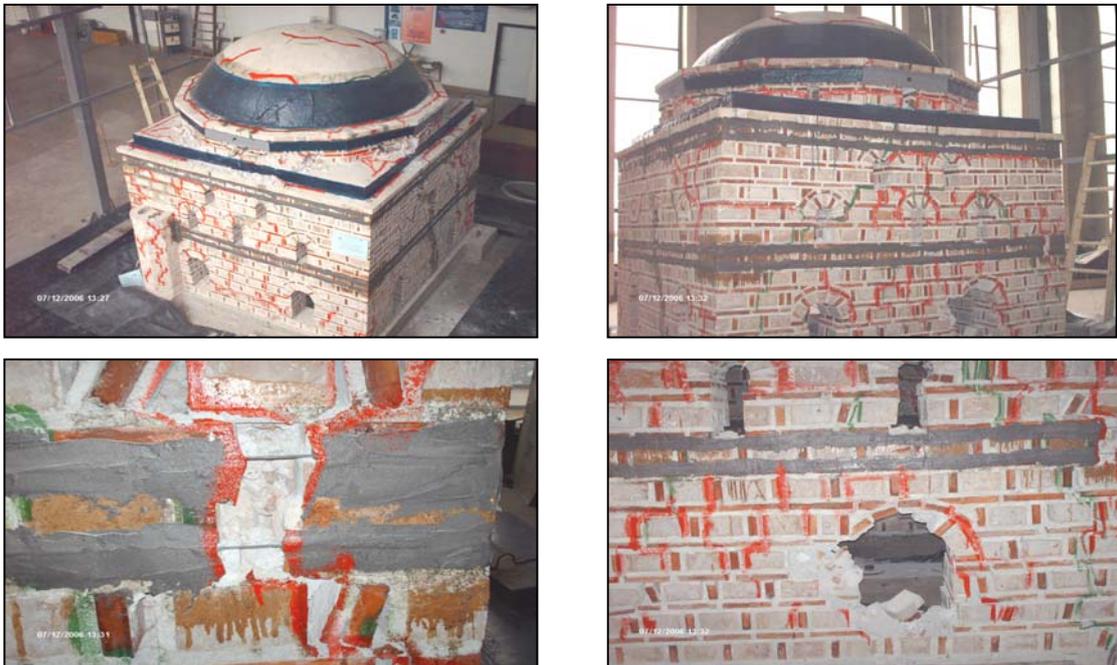
**Figure 13.** Damage of the model after phase 3 tests accomplishment

The next two tests were performed by a scaling factor of 2, under an input acceleration 0.75-1.0g. Progressive cracks appeared, but still without collapse. The final test was performed by a scaling factor of 1, under an input acceleration of 0.35g. Heavy damage occurred in many places on the dome and around the openings as well as big cracks and inclination of one corner of the model, including damage to the strengthening FRP belt at the lower level of one of the walls, after which the testing was stopped.

The damaged model and some details of damages are presented in Fig. 13. The characteristic response parameters during the seismic tests are given in Table 2. The representative time histories in the final tests are given in Fig. 14.

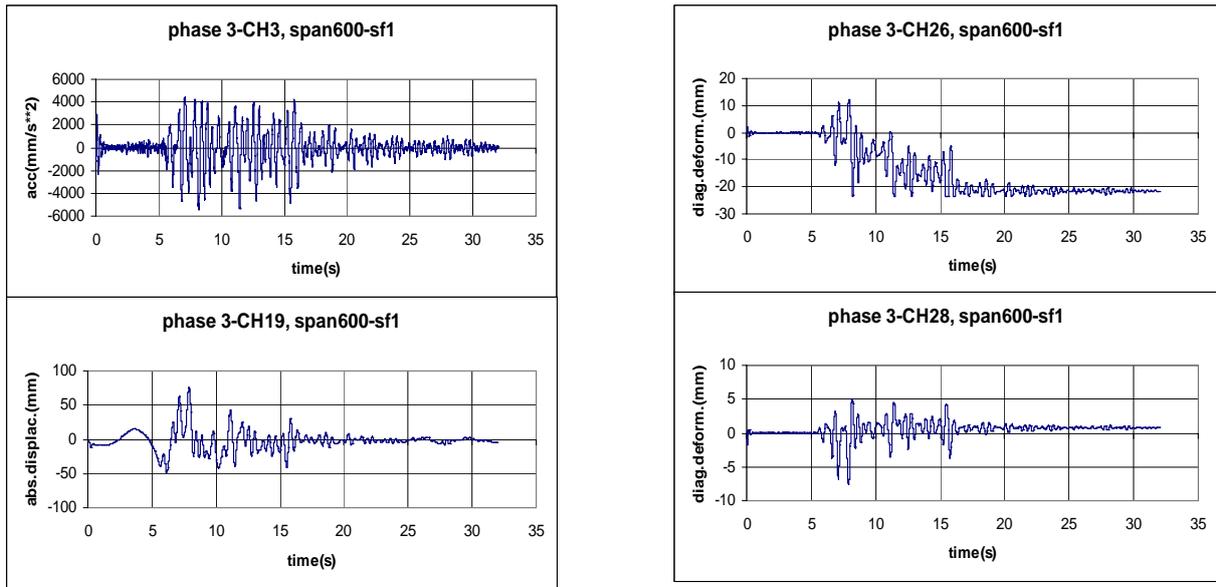
**Figure 14.** Response of the model during the last test with intensity 0.35g, scaling factor 1, phase 3
