## DESIGN OF CRANK SHAFT FOR A BRIQUETTING PRESS

SOOS Lubomir

SLOVAK UNIVERSITY OF TECHNOLOGY IN BRATISLAVA, FACULTY OF MECHANICAL  
ENGINEERING, BRATISLAVA, SLOVAK REPUBLIC

In recent years we have noticed sustainable increasing interest for biomass and energetic waste disposal. Our department has already for the past couple of years intensively focusing on the development of new machineries for waste disposal. One of them is the briquetting press BL 50-250. This article is dedicated to designing problems and the operation of a crank shaft for this press.

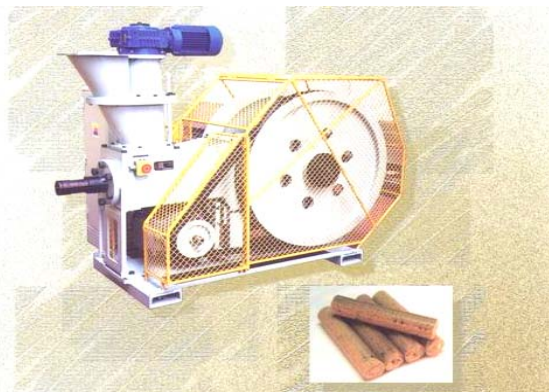
Fig. 1 Briquetting press BL 50-250

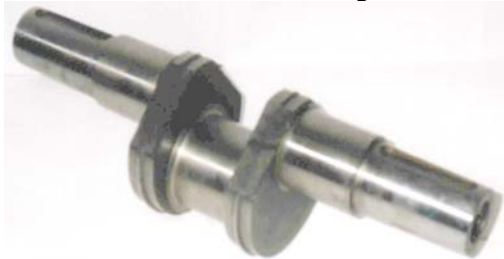
we do not know real pressures. The second problem that arises is that of peak – breakdown pressures, where these values might several times overcome nominal values of the pressure. The radius of the crank shown on Fig. 3 is 60 mm, i.e. the crank assures a stroke of the pressing piston 120 mm. Typical revolutions of the crank shaft are  $308 \text{ min}^{-1}$ .

Fig. 3 Crank Shaft of the BL 50-250 press

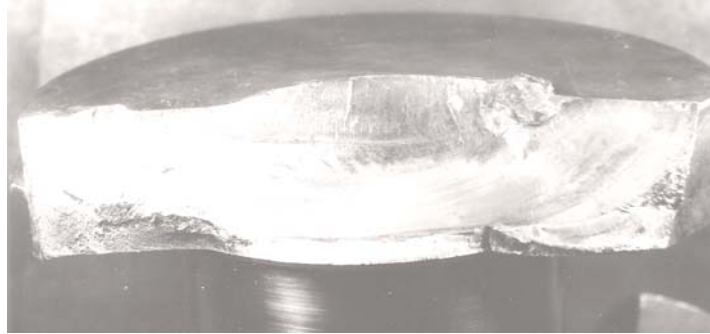
The metallographic analysis showed the reasons for break-downs. In case of the first break-down it is from the view of the fracture area (Fig. 5) visible, that failure of the shaft according to [5] has been caused by the fatigue mechanism.

The machine has been permanently overloaded during its operation caused by inappropriate operation. The owner did not follow recommended operational parameters of presses and has been briquetting wooden waste of larger permitted fractions for this type of press. The next factor that had an important influence was the

Fig. 5. Fracture area of the crank shaft at the first break-down (analysis ZTS MATEC, 27.1.2000)
