¹Maria NICOLAE, ²Irina VÎLCIU, ³Emanuela-Daniela STOICA

RESEARCH ON THE MECHANISM OF DAMAGE LINE BRICKS IN THE SLAG LF

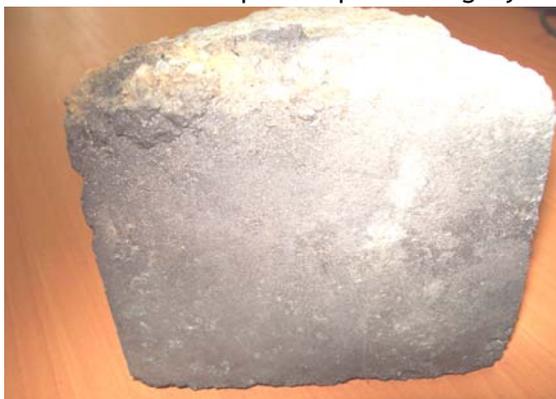
The slag deposited thickness on the refractory brick varies between 3-6 mm (fig.1).

Fig.1. Deposited slag on brick after its used in LF

The bricks appearance is shown in Figure 1 and in figure 2 is presented the bricks appearance after removal of an important part of slag layer deposited.

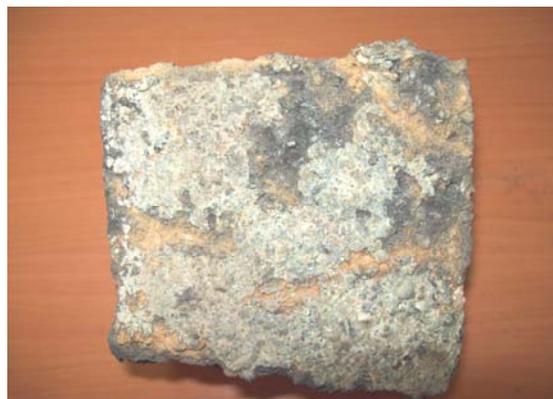
Fig.2. Interface between slag layer and brick

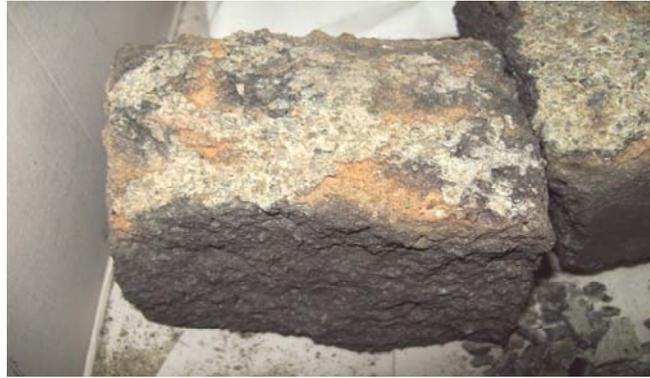
The removed slag was analyzed chemical and structural. The results are in table 3. Slag layer shows pores and two different layers (Fig. 3). These layers contain phases and micro structural aspects of different chemical compositions.

- ❖ First layer has 2.2 mm thickness and it is composed from dendrites crystals of magnesium oxide, iron oxide, iron and calcium aluminates and calcium crystals silico-aluminates. All these are immersed in a matrix of calcium aluminates.
- ❖ The second layer has 3 mm thickness and it is composed of magnesium crystals damaged by iron and manganese aluminosilicates crystals with different contents of calcium, iron and titanium, calcium aluminates - magnesium - iron and calcium silicate crystals.

Fig.3. Two of slag layers
