# ANNALS of Faculty Engineering Hunedoara – International Journal of Engineering

## ASSESSMENT OF CRACK PROPAGATION MODE IN MARTENSITIC STAINLESS STEEL HAZ WITH ELECTRON BACK SCATTER DIFFRACTION: EFFECTS OF ENVIRONMENTAL VARIABLES

**ABSTRACT:** In this study, an assessment of crack propagation mode in martensitic stainless steels heat affected zone was carried out with electron back scatter diffraction (EBSD) with focus on the effect of environmental variables. Girth welded samples were subjected to four point bend tests in sour and sweet environments. Scanning electron microscope and electron back scatter diffraction technique were both used to study the crack propagation mode and interaction of crack tip with microstructures. Study showed that sample tested in sour environment failed with transgranular cracking and samples tested in sweet environment failed with intergranular stress corrosion cracking mode. The proposed mechanism for the failure was sulphide stress corrosion cracking and intergranular precipitation of carbide by sensitisation process respectively. The correlation between crack path and grains misorientation was studied with aid of EBSD technique.

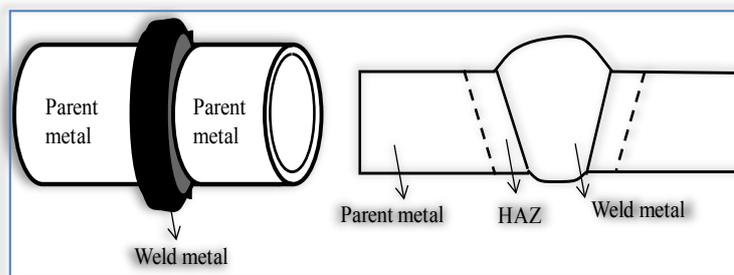
**Figure 1:** Schematic diagram of weldment showing parent metal, HAZ and weld metal

The welding was carried out with power source biased towards DC-electrode positive (DC-EP), this ensures electrons are accelerated from negative work piece onto the positive electrode with sufficient energy to melt the filler wire (Messler, 2008). The schematic diagram of the weldment is shown in Figure 1.

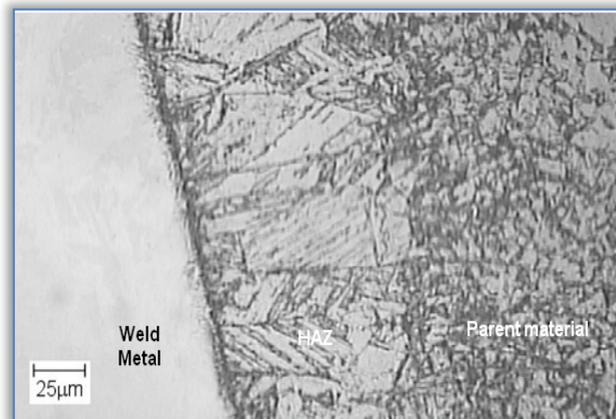
The result of optical metallography of the weldment etched in picral is shown in Figure 2. The two obvious phases observed in the micrograph were martensite and ferrite phases. Retained austenite was not observed in the weldment. On the right hand side (RHS) of the micrograph was the parent material. The parent material contained equiaxed grains of martensite. The parent material was predominated with martensite with little amount of ferrite in the structure. The left hand side (LHS) of the micrograph in Figure 2 showed the weld metal. The plan nature of the weld metal was attributed to the higher corrosion resistance of weld metal. This result is consistent with the expectation because of the relatively higher corrosion (etchant) resistant superduplex stainless steel filler used for the fabrication. The HAZ covered about 50  $\mu\text{m}$  region between the parent (RHS) and weld (LHS) metals. This is shown in the middle of the micrograph in Figure 2. The HAZ have experienced grain growth with relatively larger grain sizes. The HAZ was dominated by large martensite plates.

**Figure 2:** The Optical Micrograph of As-Welded Specimen Etched with Picral. The Micrograph Showed the Parent Material the HAZ and the Weld Metal

1. Metallographic examination of martensitic stainless steels revealed the classical regions of the weldment namely: the parent material; the heat affected zone; the weld metal.
2. The parent material was predominately equiaxed grains of martensite and the heat affected zone contained coarse martensite platelets.

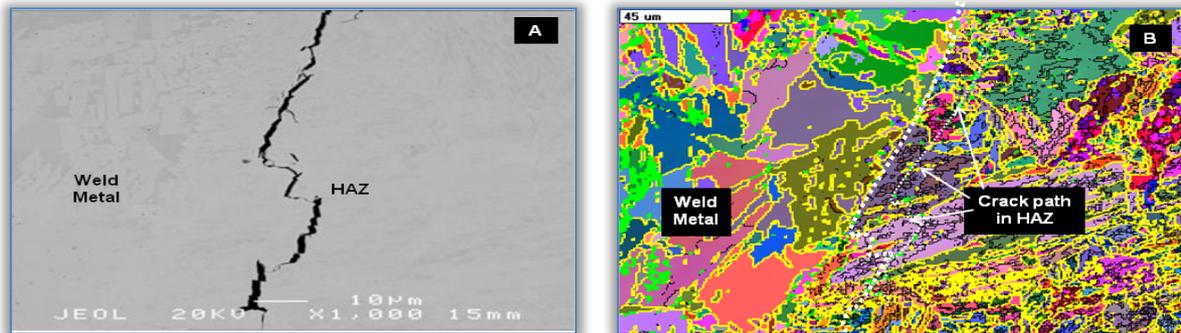
The results of scanning electron microscopy and electron back scatter diffraction carried out on specimen W2AXII tested in sour environment are shown in Figure 3. Figure 3A shows the SEM image of the cracks tip and the EBSD map of the cracks tip is shown in Figure 3B.

In specimen W2AXII, the whole length of the crack occurred in the high temperature region of HAZ close to the fusion boundary. The crack path was initially close to the fusion boundary but the tip of the crack deflected towards the middle of the HAZ as shown by arrow heads in the Figure 3B. It is equally evident from Figure 3B that the crack path cut across the grains in the

HAZ. It can therefore be suggested from EBSD micrograph that the crack in specimen W2AXII was transgranular crack. The crack was tracked with dotted line for easy visibility. The morphology of the cracks in W2AXII tested in sour environment was predominantly transgranular in nature.

**Figure 3:** SEM Micrograph and EBSD Map of Specimen W2AXII Tested in Sour Environment Containing

Containing 1 bar CO<sub>2</sub>, 0.04 bar H<sub>2</sub>S, 25% NaCl, 500 ppm NaHCO<sub>3</sub>, pH of 4.5 and Temperature of 25°C

It is reasonable to link the observed cracks in the specimen with concentration of corrosion species in the environment, while the severity of the crack is not unconnected with acidity which is a function of pH level in the testing environment. Specimens W2AXII was exposed to environment containing hydrogen sulphide (H<sub>2</sub>S) partial pressures of 0.04 bar (see Table 2). The likely chemical reaction due to the presence of H<sub>2</sub>S in the environment is contained in Equation 1. The results indicated the possibility of reaction between the steel and H<sub>2</sub>S in the presence of water. The atomic hydrogen which occurred as a reaction product may diffuse into the lattice point, particularly the interstitial site and combined to form gas molecule. The presence of atomic hydrogen and hydrogen gas in interstitial site and areas of imperfection may render the material susceptible to SSC by hydrogen embrittlement (Gerus, 1974).

3. The cracks in four-point bend specimens tested in sour environments containing H<sub>2</sub>S failed by sulphide stress corrosion cracking. The cracks were transgranular in nature. Sulphide stress corrosion cracking is likely to have occurred as a result of infiltration of atomic hydrogen into the interstitial sites with the formation of H<sub>2</sub> at crystallographic imperfections within the material.

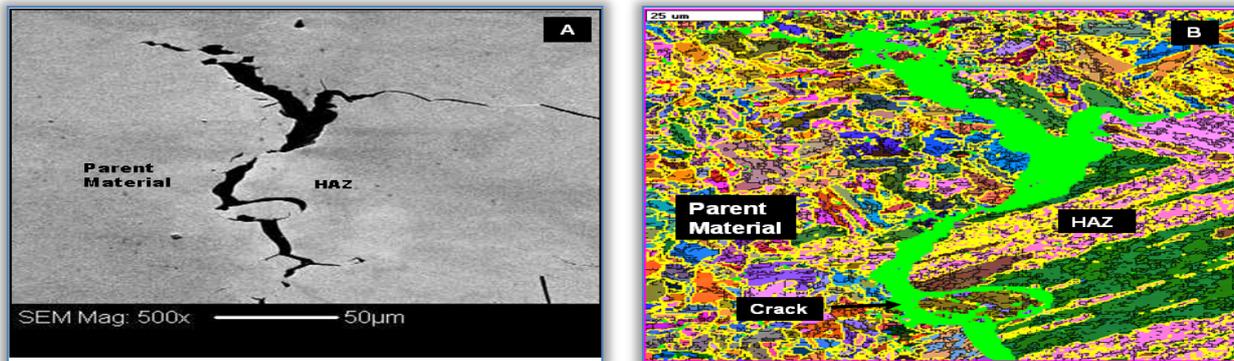
The results of scanning electron microscopy and electron back scatter diffraction carried out on specimen W2AVII tested in sweet environment are shown in Figure 4. Figure 4A shows the SEM image of the cracks tip and the EBSD map of the cracks tip is shown in Figure 4B. The cracks initiated at the weld root and propagated in the HAZ within the neighbourhood of the fusion boundary with characteristic features of intergranular cracking. The cracks tip navigated across the HAZ along the grain boundaries into the parent material. The branches along the crack path and the crack tips (Figure 4) are overwhelming evidences of intergranular cracking. The size of the crack was relatively wider than those found in the sour specimens. This observation is consistent with the finding of Coudreuse *et al.* (1999).

**Figure 4:** SEM Micrograph and EBSD Map of Specimen W2AVII Tested in Sweet Environment Containing 10 bar  $\text{CO}_2$ , 25% NaCl, 0 bar  $\text{H}_2\text{S}$ , 0 ppm  $\text{NaHCO}_3$ , pH of 3.3 and Temperature of  $110^\circ\text{C}$

The occurrence of intergranular cracks in specimen W2AVII is consistent with the mechanism of sensitization. Sensitization occurred as a result of precipitation Cr carbides preferentially along the prior austenite grain boundaries and in effect, leading to depletion of Cr content to the level below the requirement for corrosion resistance of the steel (Turnbull and Griffiths, 2003, Woollin, 2007, Woollin and Carrouge, 2002). The presence of carbides on the grain boundaries with a resultant low level of Cr within the immediate vicinity of the precipitates may make the grain boundaries to be anodic to its surrounding. Eventually, micro-galvanic corrosion may occur as a result of this process and the material becomes more susceptible to intergranular stress corrosion. On the other hand, the high density of C and N in the weld metal as a result of super duplex stainless steel filler may allow diffusion of these elements across the fusion boundaries into the high temperature HAZ. The C and N enrichment may be another justification for sensitization in the neighbourhood of fusion boundary region where the crack propagation was more dominant. These explain the reason for the occurrence of intergranular cracking in specimen W2AVII. Although considering the test temperature of  $110^\circ\text{C}$ , transgranular cracking is least expected in the specimen. However, the possibility of a ductile bridge cannot be overruled because of the higher temperature. The suggestion of ductile bridge is evident from the morphology of the crack in Figure 4 which showed an 'O' ring along the crack path in the HAZ.

On the other hand, the branches along the main crack and the tip of the cracks (Figure 4B) propagated along the prior austenite grain boundaries in the HAZ and in the parent material. It is supposed that disorientation between grains will have significant effect on intergranular crack growth. Disorientation is the minimum angle through which adjacent grain must be rotated to align it with its neighbour (Humphreys, 2001). If that be the case, one may expect easy crack growth in the region with low disorientation and vice versa. The disorientation in the HAZ is relatively lower than in the parent material. And, weld metal has almost double the disorientation in the HAZ. Most of the intergranular cracks occurred in the HAZ on both sides of the weld rather than the parent material. There was no crack in the weld metal.

4. The specimen tested in a sweet environment showed cracks which are dominated by intergranular features. The mechanism of intergranular stress corrosion cracking is consistent with intergranular carbide precipitation by sensitisation process in the heat affected zone.
