<sup>1</sup>M.T. AUDU, <sup>2</sup>A.A. RAHEEM

## FLEXURAL BEHAVIOUR OF FANPALM REINFORCED CONCRETE SLABS

<sup>1</sup>Department of Civil Engineering, University of Abuja, FCT, Abuja, NIGERIA

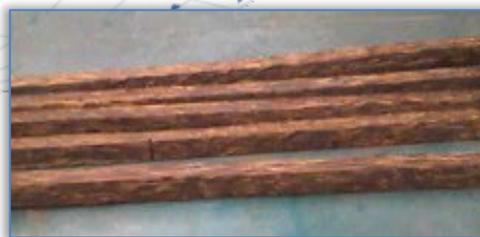
Figure 1: Samples of fanpalm reinforcement

Tap water, ordinary portland cement, washed erosion sand, local gravel of 20mm maximum size and sliced fanpalm were used. Concrete mix of 0.65: 1: 2: 4 that is the ratio of water to cement to fine aggregate to coarse aggregate which gave an average compressive strength of 20 N/mm<sup>2</sup> was used for the production of the three sets of slabs from the nine numbers wooden molds of 880 x 880 x 70 mm that were made. The wooden molds were cleaned oiled and placed on the flat and smoothed concrete base. Fanpalm logs were sliced trimmed and smoothed to 10 x 10 mm and 12 x 12 mm reinforcements' sections using hack saw and smoothing machine. Figure 1 showed samples of the sliced and smoothed fanpalm ready for used as reinforcement in the slabs.
