FLEXURAL BEHAVIOR OF CONCRETE BEAMS CONTAINING CERAMIC WASTE AS REPLACEMENT OF COARSE AGGREGATE

Abstract: The paper presents results of the investigation conducted to evaluate the flexural performance of unreinforced and reinforced concrete beams with ceramic waste as replacement of coarse aggregate. A total of forty-five (45) non-reinforced beams (150x150x750mm) and ten (10) reinforced beams (150x250x2150mm) were used to investigate the flexural behavior of the specimens. The flexural parameters investigated are crack formation and pattern, failure mode, ultimate load, theoretical and experimental ultimate moments, and deflection. From the results of the investigation, the increase in ceramic waste content led to substantial decrease in the failure load which produced higher experimental moments when compared to theoretical moments. Generally, sudden failure mode was observed for all unreinforced specimens with cracks formed about the mid-span of the specimens. Diagonal cracks were observed in the reinforced beam test specimens and failure mode was diagonal tension failure with cracks propagating from the tension face towards the compression face. The investigation further showed

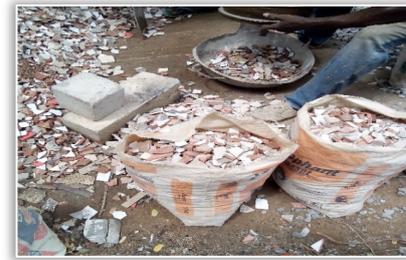
The cement was Ordinary Portland cement (Grade 32.5R) produced in accordance to [11] and [12]. Ceramic Waste used was obtained from on-going construction sites within the University of Lagos, Nigeria. The crushing of ceramic wastes was done manually and made into smaller pieces of about 5-40mm sizes by a hammer. These small pieces were then fed into stacked vibrator sieves to get the required 12.5 -19mm size. The coarse

Figure 1- Crushing and Sieving of Ceramic Waste

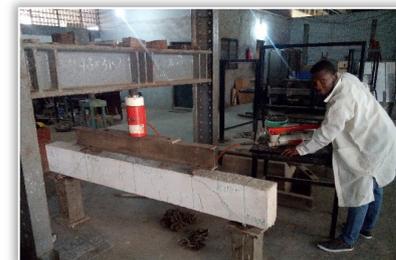
Figure 3- Laboratory Testing

The replacement of granite with ceramic waste in the beams was varied from 0 to 100% at 25% increment (based on preliminary findings). Beams without ceramic waste served as control. Beam specimens were produced and tested under the third point loading (Figure 3) in accordance with [16]. A dial gauge was placed under the beam at the mid-span to measure the deflection at regular interval of loading. The load at which the first visible crack occurred was noted and recorded; so was the load at which failure occurred. The tests were terminated when a little increase in load led to a very large deflection. A total number of 10 beams were cast and tested at 28-day curing age.

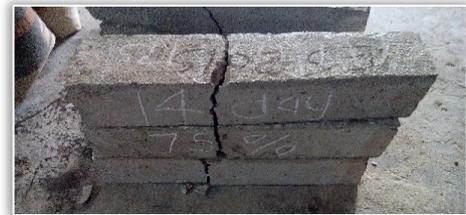
From the tests conducted on the beams (150x150x750mm), the crack and failure patterns were similar for all mixes as shown in figure 5. The failure of the beams was seen to occur at almost the Centre of the beams, 380mm from either side of the beams, No cracks were observed prior to the failure of the beams. The failure was sudden without initial crack(s) preceding the ultimate failure of the beams. The sudden failure of the beams can also be attributed to the exclusion of steel reinforcement which contributes immensely to the flexural strength of concrete beams.

Figure 5-Failure Mode of Concrete Beam
