CONSIDERATIONS REGARDING THE SCC TESTING OF OLT45.3K STEEL WELDS

Andreea BOBIC, Doru Romulus PASCU

ISIM TIMIȘOARA

The paper presents the obtained results following from the verification of the SCC specimen tested on specific circuits by visual examination, free bending testing, metallographic examination and hardness testing.

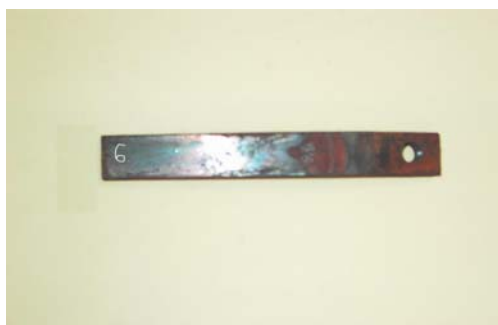
Figure 1. Specimen 6
The aspect of the specimens (pre-tensioned before testing) subjected

The state and aspect of examined specimens performed the respecting of the specific conditions imposed by the testing procedures of similar welded joints and of the surveillance instructions. So, specimens have no solid substance depositions coming from the corrosive steam. The fluid acted on the tensile surface continuously by the initial and on going correct adjustment. The aspect of the specimens is presented in figure 1 and the details of the tested surfaces are presented in figure 2.

All the examined surfaces presented no corrosion cracks on the areas subjected to testing. The predominant color of the tested specimens is grey to black and characterizes the effect of the solid substance in the corrosive fluid.

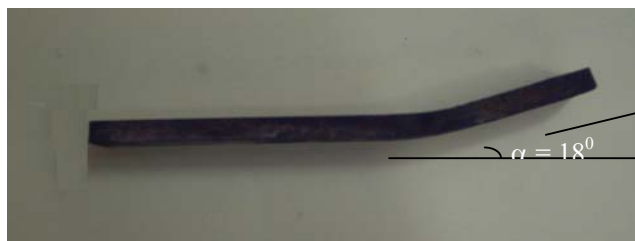
Figure 3. Specimen 6

to SCC testing is represented in figure 3.

The residual strains obtained by bending in the device are about 8%, corresponding to the 18° angle (figure 3).

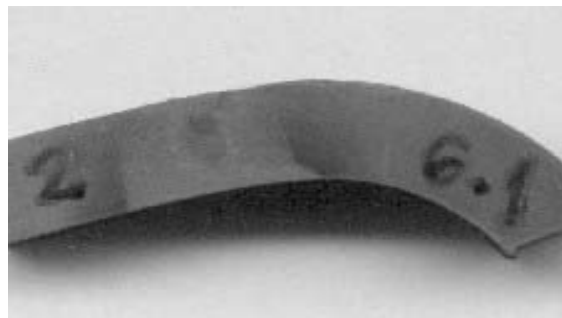
The macroscopic examination of the SCC specimens longitudinally sampled at the "6" sample subjected to the corrosive action of the overheated steam (figures 4 ... 7) evinced no corrosion cracks.

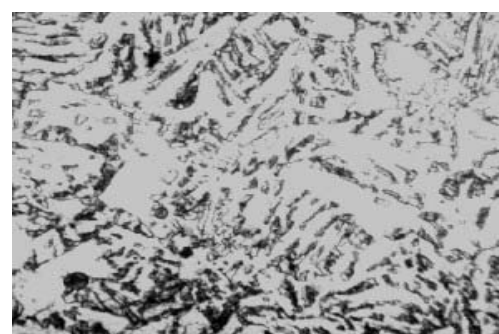
- ◆ In the weld (WELD), the structures are dendritic pearlitic ferritic with elongated dendrites on the thermal flux direction and on the restrained areas acicular ferrite structures were developed, which do not exceed 2 points (W2), according to STAS 7626 (figures 12 ... 19)

In the examined welds were found no welding defects such as microcracks and corrosion microcracks type defects due to the corrosion phenomena of the steam. "The corrosion spot" was formed in the direct contact area steam - specimen where the most corroded areas appear, the other areas present reduced corrosion phenomena, the corrosion depths varies between 0.03 and 0.11 mm.
