EXPERIMENTAL VERIFICATION OF AN APPROXIMATE TECHNIQUE FOR DAMAGE IDENTIFICATION IN BEAMS USING NONLINEAR REGRESSION ANALYSIS OF BENDING FREQUENCY CHANGES

ABSTRACT:

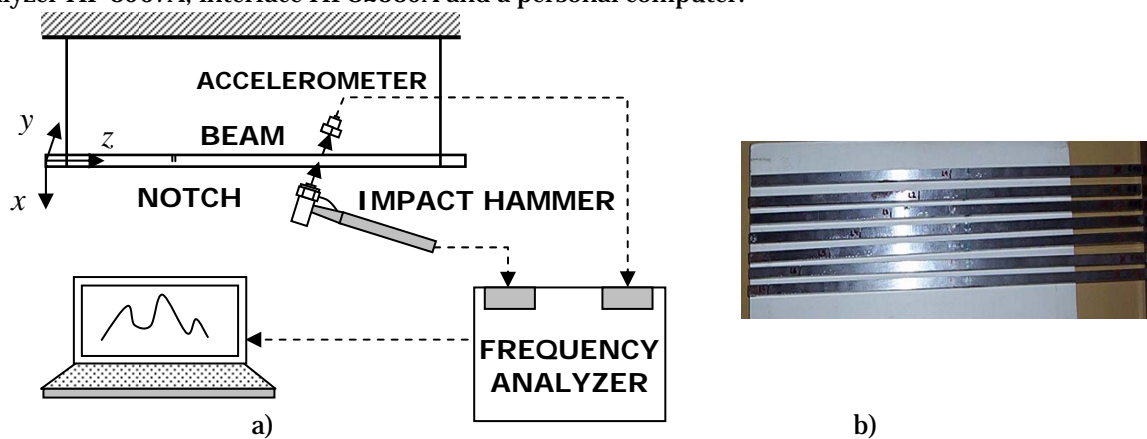
The experimental setup is shown on Fig. 4a. The instruments used in this experimental study were: impact hammer B&K 8202 with load cell B&K 8200, accelerometer B&K 4394, frequency analyzer HP 3567A, interface HP82335A and a personal computer.

Figure 4. Experimental setup: a) scheme; b) seven beam samples

Experiments were performed on seven beam samples in free-free boundary conditions, Fig.4b. The free-free state is attained by hanging a beam using two thin silicon ropes. Cracks of varying depths are made with a saw at different locations on beams. Since the crack is made with a thin blade (1mm in width), the crack always remains open during the vibration test. Each beam model was made of a steel bar with a nominal cross-sectional area 8 mm by 8 mm and a length of 400 mm. The frequency measurement was performed twice for each of 7 undamaged beams and 28 combinations of crack locations and depth.

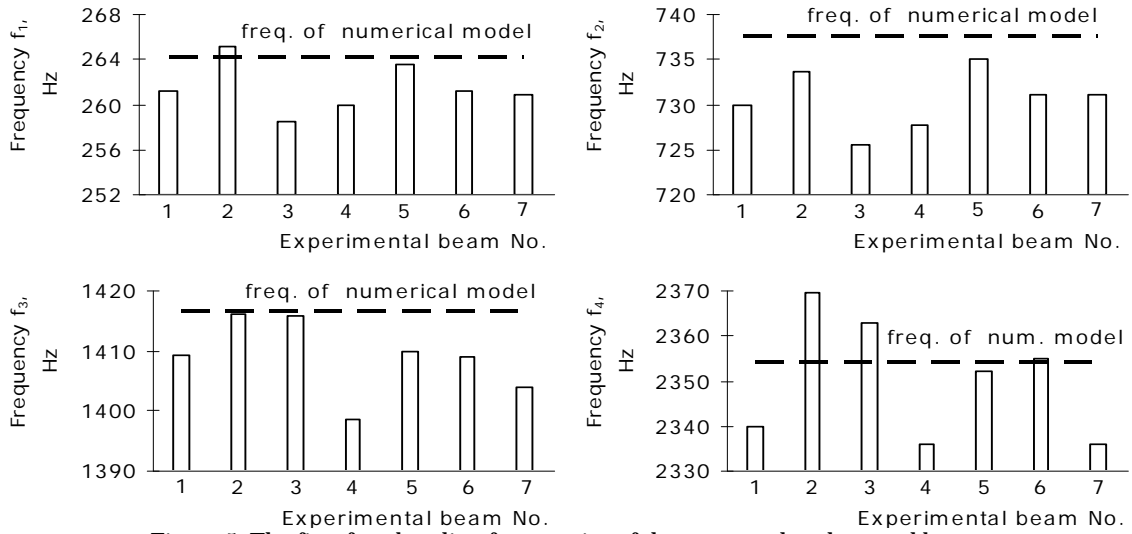
Figure 5. The first four bending frequencies of the measured undamaged beams in comparison to the frequencies of the numerical model

The previously established numerical model and regression curves were used for all measured beams despite slight discrepancies in their dimensions and frequency values in undeformed state, Fig.5. This means also that there were the differences between the unique numerical model and these seven measured beams, but on the other hand this enabled to check the robustness of the proposed technique. Of course, in real practice, the efforts should be put to establish the numerical model that fits the real structure the best, which will give more chance to the better identification results.

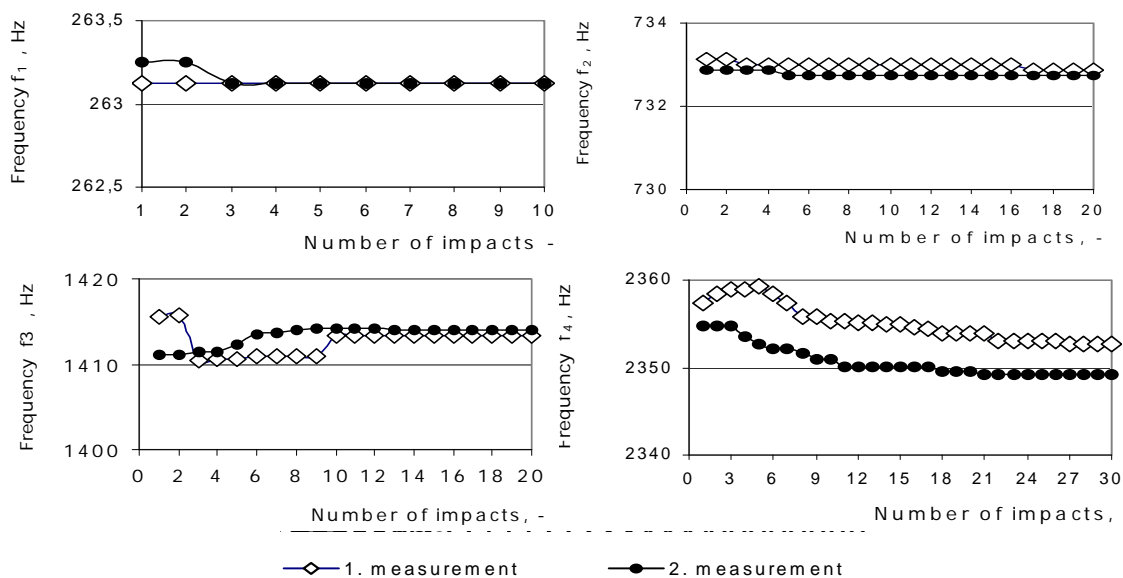
Figure 7. The values of the first four bending frequencies in dependence on the number of impacts for two independent measurements

The number of impacts were chosen in dependence of the beginning of frequency value stabilization, Fig.7, except for the fourth frequency where higher number of impacts (20 or 30) would require a lot of measurement time.
