¹. I. I. AHMED, ². T. YAHAYA, ³. J. A. ADEBISI, ⁴. N. I. AREMU, ⁵. A.G.F. ALABI, ⁶. S.B. LYON

STRESS CORROSION CRACKING OF AUSTENITIC STAINLESS STEELS IN POTENTIOSTATICALLY CONTROLLED CHLORIDE ENVIRONMENTS AT AMBIENT TEMPERATURE

^{1,6}. Materials Performance Centre, University of Manchester, Manchester, M13 9PL, UNITED KINGDOM

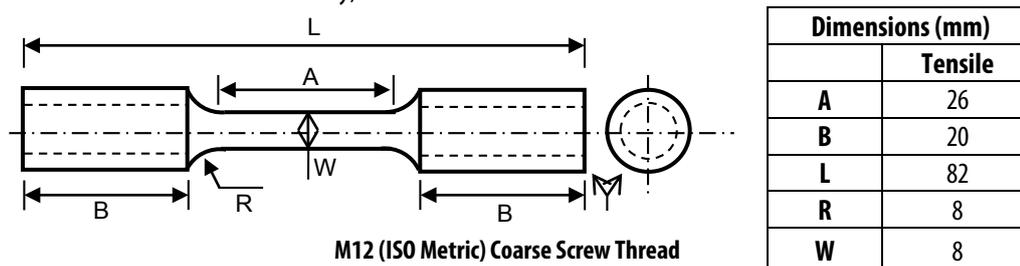
Figure 1: Schematic Diagram of the Slow Strain Rate Test Specimen and Dimension

The slow strain rate test was carried out on 100kN Instron 5500R equipped with Bluehill software for test and result analysis. The tensile specimens used were machined from the centre of the plates along the prior longitudinal directions. A schematic diagram of the tensile specimen and its dimensions are shown in Figure 1. Typical sample name used include ANL which represents annealed sample made from longitudinal direction. Preliminary sample preparation included wet grinding and polishing with increasingly fine silicon carbide paper in order of 400, 600, 800 and 1200 grit sizes to remove machining grooves. The sample was then degreased with acetone and later rinsed with deionised water. The sample surface area to be exposed to electrolyte was measured for subsequent calculation of corrosion current density, while other area was insulated from the environment with wax.

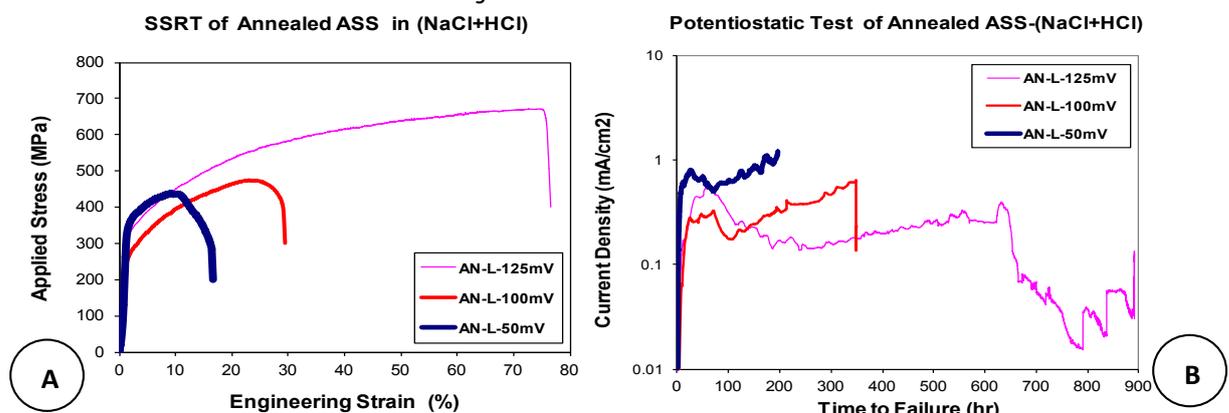
Figure 3: SSRT Curves for Annealed Samples Tested at Strain Rate of $2.4 \times 10^{-7} \text{ s}^{-1}$, pH of 1.5, and Applied Potentials of -125mV, -100mV and -50mV at Ambient Temperature: Applied Stress Vs Strain (A) and Current Density Vs Time to Failure (B)

The results of stress corrosion cracking tests are shown in Figure 3. The plots of applied stress against engineering strain and the plot of current density against time to failure are shown in Figure 3A & B respectively. The detailed results of tests are contained in Table 2. The effect of applied potential was quite obvious from the Plastic elongation (ductility), the Ultimate Tensile Strength (UTS) and from Time to Failure (TTF).

The ductility and ultimate tensile strength of material decrease as the applied potential increases. Similarly, time to failure also decreases as applied potential increases. The decrease in the time to failure and mechanical properties of the material may be attributed to significant increase in the corrosion rate caused by increase in the applied potential. The plots of corrosion current density against time to failure in Figure 3B showed that corrosion current density increases as applied potential increases. The increased corrosion current density with time to failure was attributed to crevice corrosion between the elongated sample and the SCC cell. The plot of corrosion current density against time to failure also showed that first current peak coincided with onset of plastic elongation. The curve showed a repeated pattern of sudden increase in corrosion current density followed by gradual decay with time, which is characteristic of stress corrosion cracking failure.

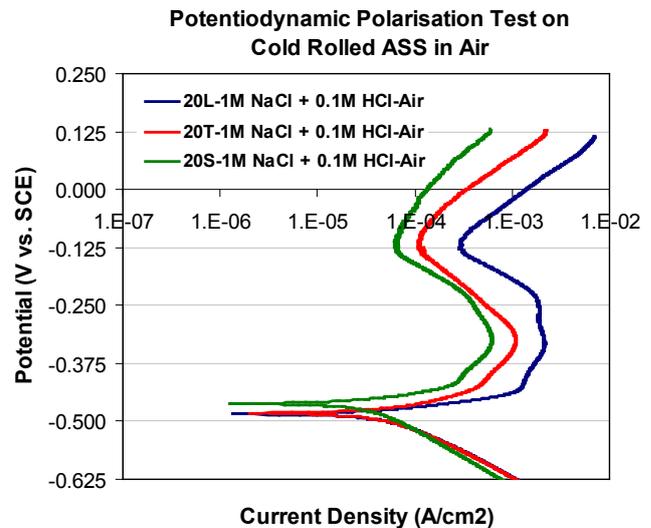
Figure 2: Potentiodynamic Polarisation Measurement on 20% Cold Rolled ASS, Type 304L, in Solution containing 1M Sodium Chloride + 0.1M Hydrochloric Acid at Scan Rate of 0.1667mV/s in Aerated and Ambient Temperature Conditions

The results of preliminary test carried out on three orthogonal planes of 20% cold rolled samples are shown in Figure 2. Preliminary polarisation scan was necessary to inform the choice of range of applied potentials needed for the SCC test. The polarisation scan was carried out on deformed sample which was only available rather than annealed material used in SCC test. This is not expected to affect the objective of the study on the basis of earlier studies (Mazza et al., 1979, Fu et al., 2009) which have shown that primary

passivation is not significantly affected by deformation degrees. Hence, the choice of three potentials (-125mV, -100mV and -50mV) investigated in the SCC test, was made from the preliminary Potentiodynamic polarisation measurement. Two of the applied potentials (-100mV and -50mV) fall within the metastable pitting potential region, while -125mV corresponds to the passive potential that allows the material to maintain a protective corrosion resistance passive film.

It was also observed from Figure 2 that, the applied potential was not affected by the test sample direction, while the corrosion current density showed an obvious difference. The highest corrosion current density occurred on the longitudinal plane (L) and least corrosion current density occurred on the short-transverse plane (S) (see Figure 2). The possible suggestion for the observed difference can be attributed to grain boundaries density on the respective planes of deformed sample.

The test at applied potential of -125mV took 891 hours before failure occurred. This was obviously too long, while failure occurred too quickly at 197 hours when the applied potential was increased to -50mV (see Figure 2) due to accelerated corrosion process. The applied potential of -125mV represents the passive potential where corrosion process was expected to be at minimal level. Hence, the SCC test was largely dominated by mechanical process.

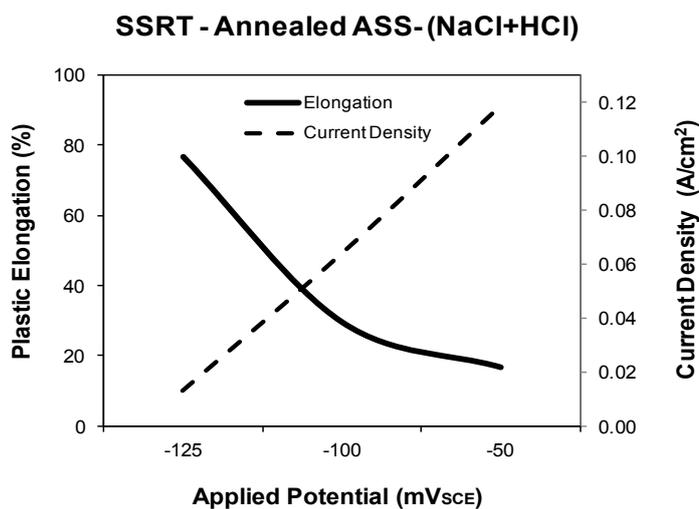
Figure 4: Effect of Applied Potentials on Plastic Elongation and Corrosion Current Density for Annealed Samples Tested in Chloride Environment at Strain Rate of $2.4 \times 10^{-7} \text{s}^{-1}$, pH of 1.5 at Ambient Temperature

The plot of plastic elongation against applied potentials is shown in the Figure 4 and the detailed results of the samples tested at different applied potentials are shown in the Table 2. The significant increase in the corrosion rate may have been the reason for decrease in the plastic elongation as the applied potential increases (see Figure 4).

The Slow Strain Rate Tests have shown that, plastic elongation, ultimate tensile strength and time to failure decrease as the applied potential increases. The plastic elongation was significantly reduced when applied potential was increased from -125mV to -50mV (Figure 4). The decrease in the plastic elongation when applied potential was increased from -125mV to -50mV was attributed to the enhanced corrosion process caused by transpassive dissolution of primary passive film (Zheng and Bogaerts, 1993). The tests carried out at passive potential of -125mV demonstrated that SCC susceptibility can be arrested if test is maintained at primary passivation range. The immunity of ASS to chloride SCC was obviously improved when electrochemical potential was maintained at primary passive potential range. This improvement may be credited to the formation of stable chromium-rich passive film that continuously help to protect the substrate whenever crack or pit opens up (Burstein et al., 1993, Hashimoto et al., 1976).

Again, the rupture pattern of sample tested at applied potential of -100mV was outstanding (see Figure 4). The tangent on the curves just beyond the UTS showed evidence of gradual failure compared to samples tested at -125mV and -50mV. The test at -100mV signified the optimal condition for SCC test and represents the balance between competing effects of mechanical and corrosion factors. The applied potential must be such that it will not be too low so that failure is not dominated by mechanical process and must be too high, otherwise failure may be dominated by corrosion process. Samples tested at applied potential of -100mV seemed to represent the optimal condition as indicated by the rupture curve. This is an indication that material had sufficient time for crack propagation to actually occur before final fracture occurred. This is typical of SCC propagation where cracks grow through repeated process of film rupture by mechanical strain and repassivation of the protective chromium oxide film (Garcia et al., 2002, Sedriks, 1996).

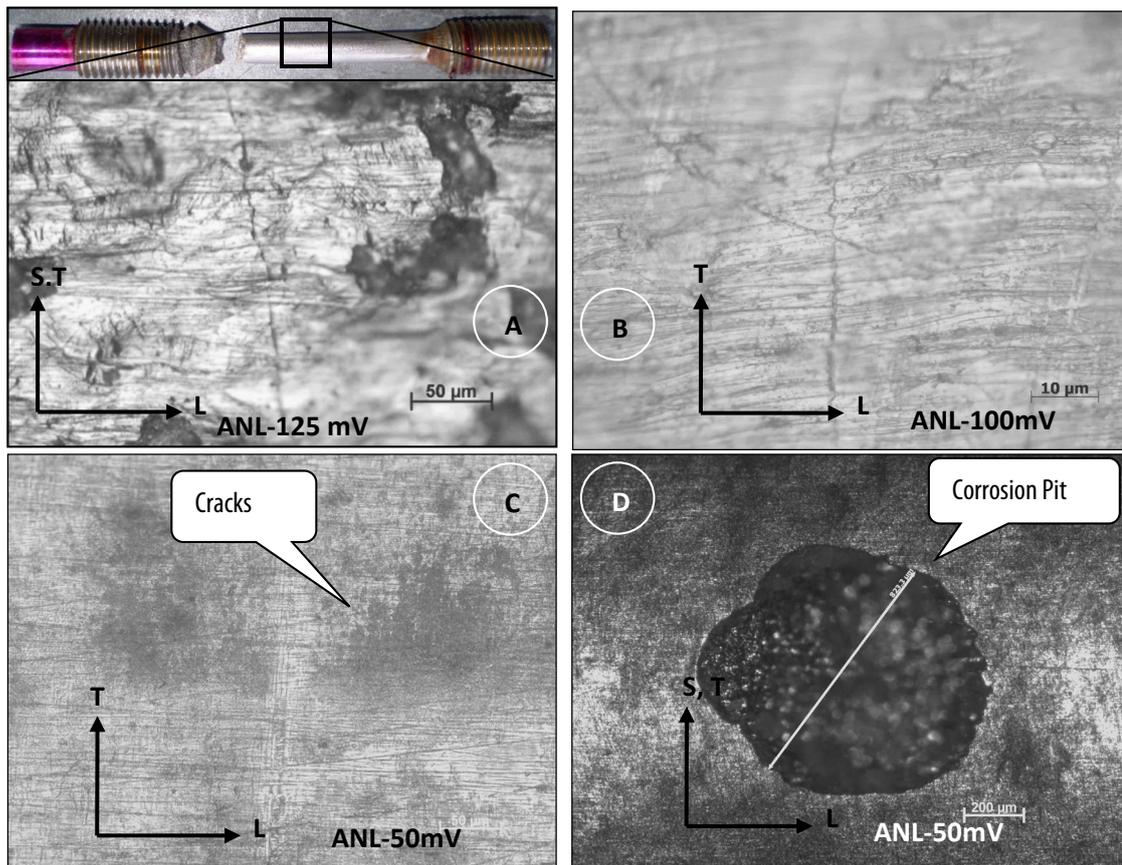
Figure 5: Optical Micrographs of Annealed Samples Tested at Strain Rate of $2.4 \times 10^{-7} \text{s}^{-1}$, pH of 1.5, and Applied Potentials of: -125mV (A), -100mV (B) and -50mV (C and D) at Ambient Temperature

The results of optical microscopy of annealed samples tested at different applied potentials are shown in the Figure 5. The three samples failed at a similar location, at the point of contact between the SCC cell and the sample. The failure at this location was probably facilitated by crevice corrosion between the cell and sample due to reduction in cross-sectional area as the sample elongated during the test. However, the cracks and corrosion pits shown in the Figure 5 were found on the gauge length area (see inset in Figure 5A). All three samples showed evidence of cracks perpendicular to the loading (longitudinal) direction.

The cracks on sample tested at applied potential -50mV are quite faint and thinner than other two samples (Figure 5C). This may have been caused by the lower plastic elongation due to accelerated corrosion process that dominated the test. In addition to the observed cracks on the samples tested at applied potential -50mV, corrosion pits of about 0.8mm diameter were also observed on the sample (see Figure 5D).

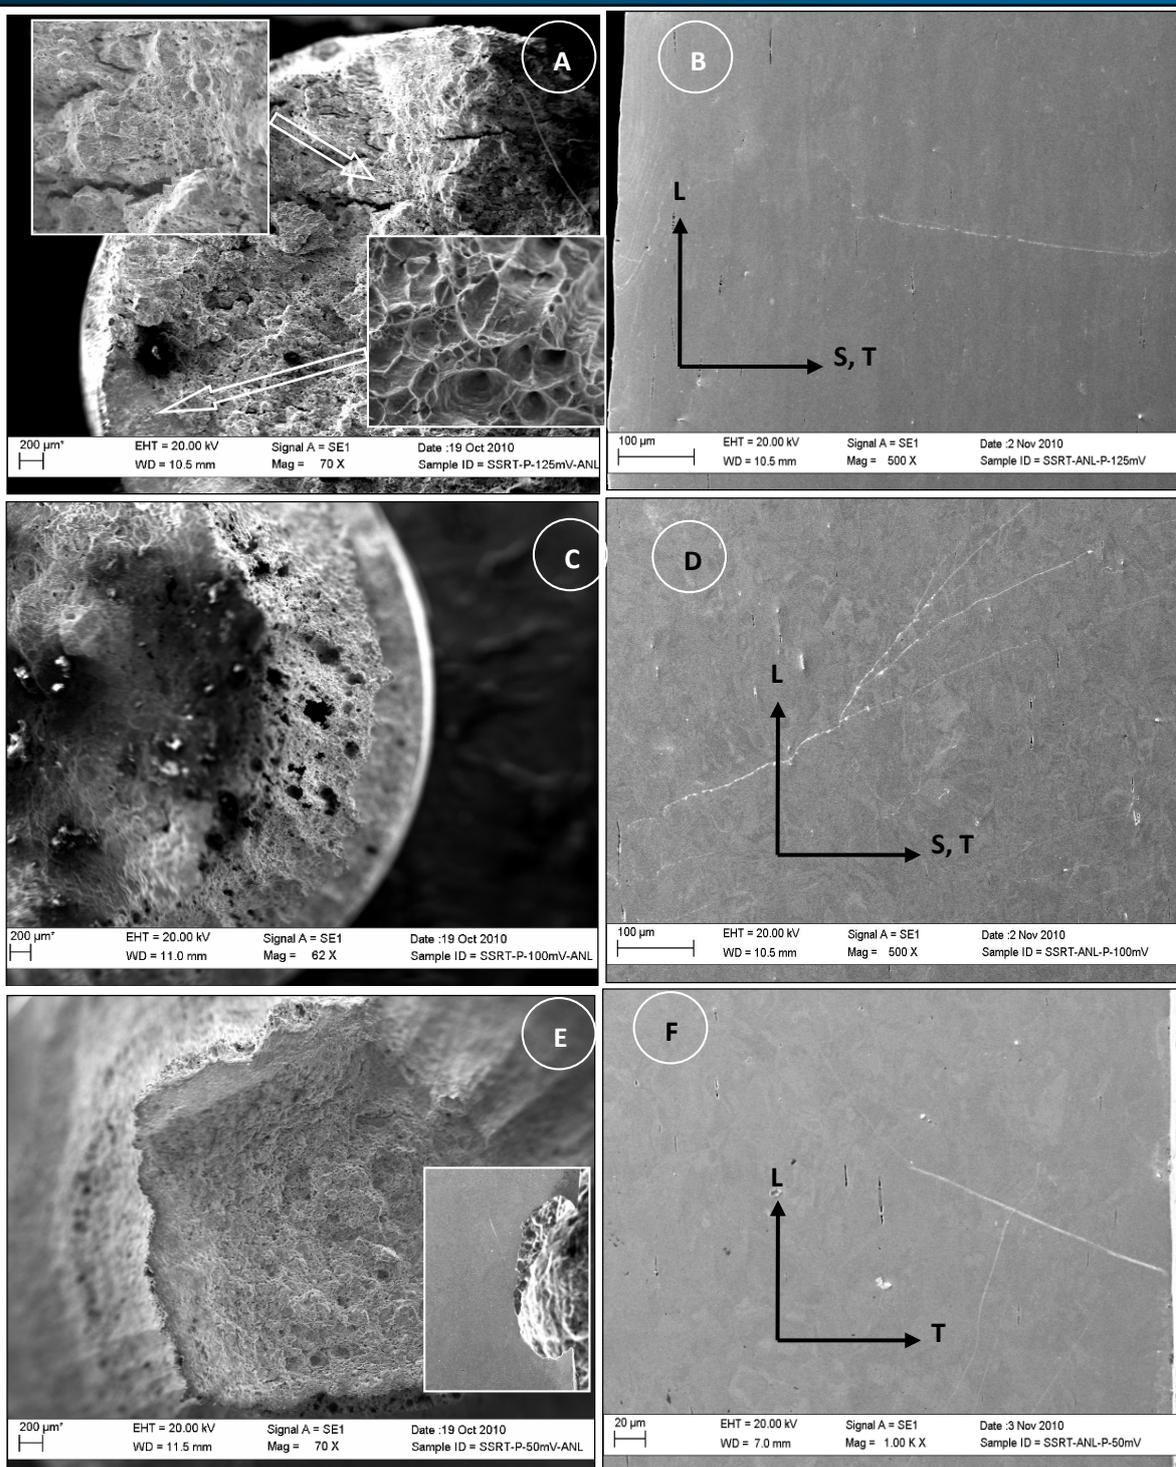
Figure 6: SEM Micrographs of Annealed Samples Tested at Strain Rate of $2.4 \times 10^{-7} s^{-1}$, pH of 1.5 and Ambient Temperature, at the Applied Potentials of: -125mV (A & B), -100mV (C & D) and -50mV (E & F), showing the Fracture Surface and Crack Cross Section, respectively.

The scanning electron micrographs of annealed samples investigating effects of applied potential on the SCC are shown in Figure 6. The fracture surface and crack cross section of sample tested at applied potential of -125mV are shown in Figures 6A&B respectively. The fracture surface showed areas of SCC with evidence of secondary cracks along the loading direction and that of pure ductile failure. The area of ductile failure were characterised by dimples (see insets in Figure 6A). It was understood from SSRT results that the test at applied potential of -125mV was dominated by mechanical process because of very low strain rate used. This may have been the reason why secondary cracks observed were more conspicuous than in other samples tested at applied potentials of -100mV and -50mV.

The SEM micrograph of crack cross section in the gauge length area is shown in Figure 6B. The cross sectional view of the sample showed evidence of crack which appeared to be quite thin. The crack was expected to be more widely opened under load prior to the final failure. Complete removal of load after failure may have led to crack closure due to elastic recovery. The crack is suggested to be transgranular crack. The single crack propagated across the loading direction without obvious branch. Fracture surface and crack cross section of sample tested at applied potential of -100mV are shown in the Figure 6C & D respectively. Additional information from the fracture surface of sample tested at applied potential of -100mV was aggressive corrosion, which was not so obvious on sample tested at applied potential of -125mV. The cross section of the crack in the Figure 6D also showed a thin crack with branches. The cracks were transgranular in nature.

The fracture surface of sample tested at applied potential of -50mV (Figure 6E) showed evidence of excessive corrosion (pitting and crevice) which dominated the process. The fracture surface also contained an area of SCC with secondary cracks and an area of ductile failure dominated by ductile dimples. The SEM micrographs of crack cross section are shown in the Figure 6F. The cracks were faint and quite thin, this may be attributed to higher corrosion rate and low mechanical process. The plastic elongation was relatively lower compared to the samples tested at the applied potential of -125mV and -100mV (see Figure 4). The inset in Figure 6F showed one of the corrosion pits and what appeared to be a crack at the root of the corrosion pit.
