ANNALS of Faculty Engineering Hunedoara – International Journal of Engineering

1. Elma EKINOVIĆ, 2. Nedim HODŽIĆ, 3. Sabahudin EKINOVIĆ

DAMAGE IDENTIFICATION IN BEAMS USING NONLINEAR REGRESSION ANALYSIS OF BENDING FREQUENCIES

¹⁻³. University of Zenica, BOSNIA & HERZEGOVINA

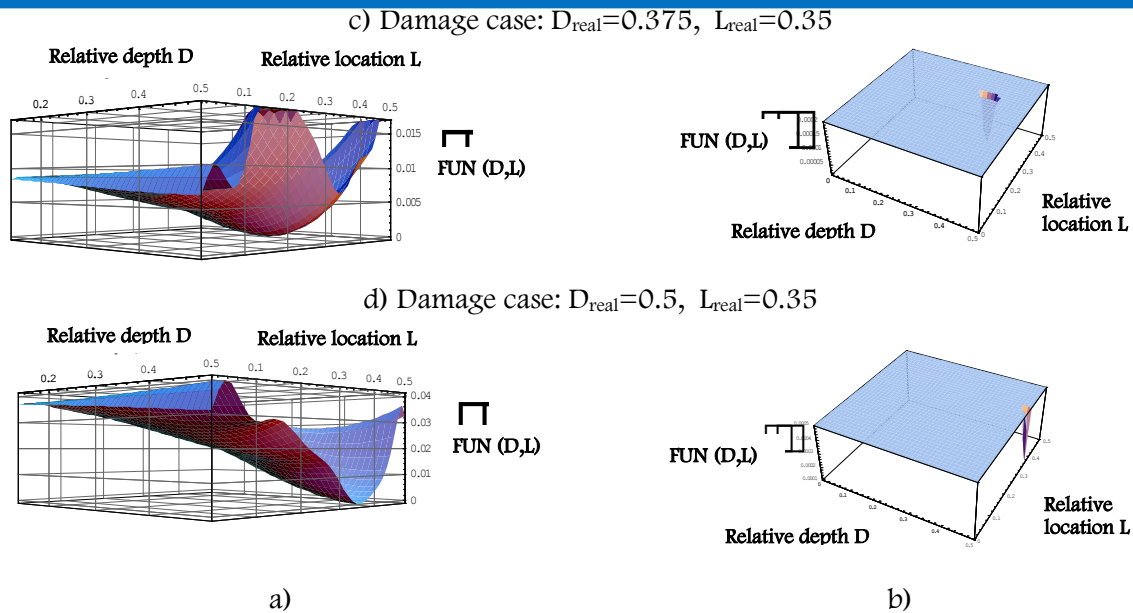
Figure 5 shows the results of damage identification (the area of FUN(D,L) minimum) obtained by use of Mathematica 5.1 for the beam sample with $L_{real}=0.35$ and four depths of the damage.

a) Damage case: $D_{real}=0.125, L_{real}=0.35$

b) Damage case: $D_{real}=0.25, L_{real}=0.35$

Figure 5. Functional $FUN(D,L)$ for 4 values of damage depth:

A) 3D view of $FUN(D,L)$; B) zoomed view on area of functional minimum

Finding the minimum of the functional FUN(D,L), the parameters of the damage D_{est} and L_{est} are estimated. The results of damage identification and relative identification errors for the specific case ($L_{real}=0.35$) are presented in Table 3. The relative identification errors are calculated by

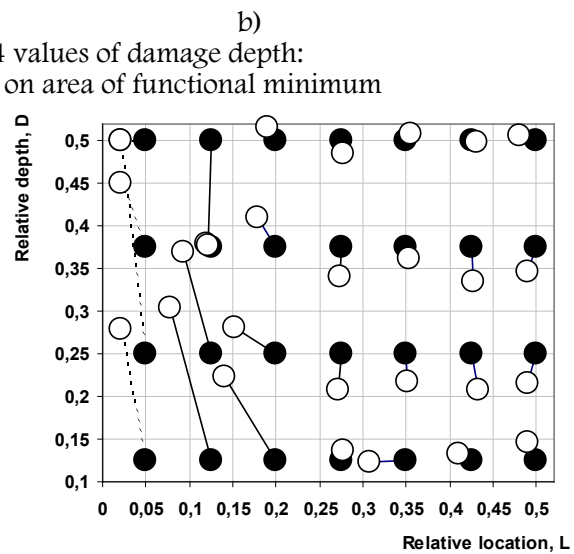
The same procedure was repeated for 4 cases of damage depths for another six beam samples. Figure 6 shows the results of damage identification for all 28 cases of damaged states (7 locations by 4 depths).

Figure 6. Results of damage identification:

● - point indicating L_{real} and D_{real} ,
○ - point indicating L_{est} and D_{est}

It should be noted that despite all modelling and measuring errors that appear here, the results of the used identification technique are quite satisfactory.

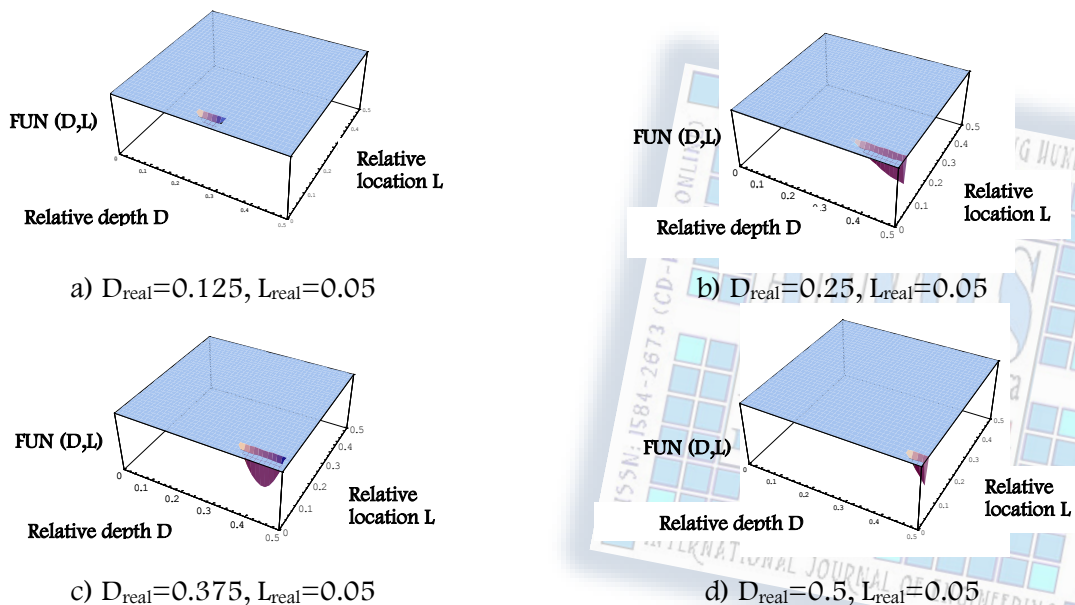
For four cases that refers to the location of $L_{real}=0.05$, the Mathematica software couldn't find the accurate numerical values of D_{est} and L_{est} for the functional minimum but using the appropriate diagrams, shown on Figure 7, the characteristic values of D_{est} and L_{est} have been defined approximately.

Figure 7. Zoomed view on area of functional $FUN(D,L)$ minimum for 4 values of damage depth for damage relative location $L_{real}=0.05$
