¹Tibebu Tsegaye ZIGALE, ¹Basavaraj PARUTI

FEASIBILITY ASSESSMENT FOR DRILLING AND REHABILITATION OF WATER SUPPLY BOREHOLE SCHEME AT AWARO CAMPUS, AMBO UNIVERSITY

¹ Department of Hydraulic and Water Resource Engineering, Ambo University, Ambo, ETHIOPIA

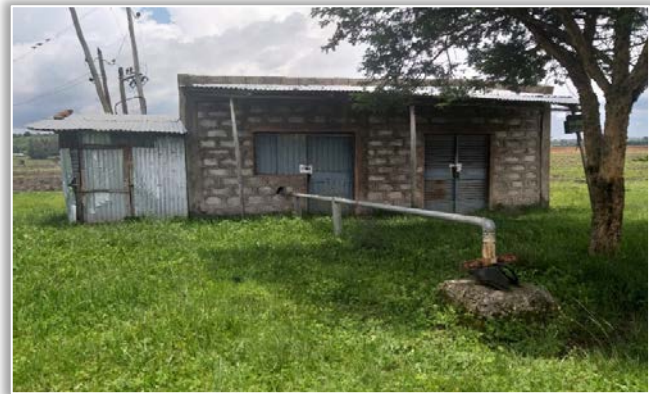
Figure 2: Awaro Campus Water Borehole

The institute of technology campus of the Ambo University which is dedicated to engineering departments, housing more than 7000 students. The existing borehole as shown in figure 2 was working with its full capacity up to 2015. But the borehole was functioning and supplying water to meet the requirements of institute from 2014. After it has been working with the yield of 25-26litre/sec at the time of construction was reduced to 14-15 liter/sec. Because of this, maintenance and borehole washing has been done, so by doing this restarted to function the institute up to the end of 2015 but without much working, because of getting reduced yield capacity of the borehole decided to stop function.

As per the field visit and data available with Ambo University, IOT, it was noted that the borehole had a yield of 25 l/s and depth of 96 meters in the year 2014. In the year 2015, it was observed that yield of borewell reduce to 14 l/s. The water quality has changed to turbid in colour with full of sediment. Eventually the borehole is not functioning now as a source of water supply in view of the accumulation of sediment in the bore hole since 2015. In view of the shortage of water supply to meet the requirement of the IOT campus, the institute decided to search for alternate source of water supply and IOT campus is depend on Ambo town water supply line which has newly inaugurated by diverting Huluka River as a source. During the field visit it was noticed that pumping control mechanism regulatory systems were failed due to the sediment accumulation in the bore hole.
