# ASSESSMENT OF CONCRETE QUALITY OF REINFORCED CONCRETE STRUCTURAL ELEMENTS OF UNIVERSITY BUILDINGS USING SCHMIDT HAMMER

<sup>1</sup>Department of Civil Engineering, Federal University of Technology, Akure, NIGERIA

**Abstract:** The quality of concrete in reinforced concrete structures can be tested either by destructive or non-destructive technique. For structures under use, non-destructive technique is preferred simply because the method affords little or no destruction of the structural elements under investigation. Schmidt Rebound Hammer test was used to assess the reinforced concrete structural elements of two University Hostels labelled A and B. From the investigation of the concrete quality according to IS 13311-2:1992, it was discovered that for the selected elements considered in Hostel A, 89% of the ground floor columns are of fair hard concrete and 11% are of good concrete layer; 67% are of very good layer while 33% are of good layer for slab and 3% of the beams are of fair quality concrete while the rest are of good qualities. However, for Hostel B, 8% of the ground columns are of good hard concrete, 78% are of fair hard layer and 14% are of poor concrete layer, while

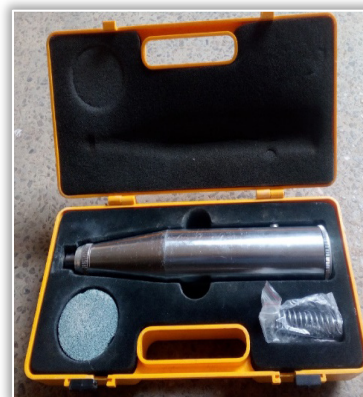
Figure 3: Schmidt Rebound Hammer

The Schmidt rebound hammer (Figure 3) is a common equipment used for several purposes. As given in [17], it is used to determine concrete uniformity, indicate areas where the quality of concrete is poor and to assess the strength of concrete, only if a correlation is generated between compressive strength and rebound index.

The equipment has a steel loaded hammer in which when pressed against the member to be tested at a right angle either upwards or downwards, vertical or horizontal, strikes the steel plunger in it. The rebound number or index is read on a linear scale at the back of the instrument while the hammer is still in the position of impact. As a rule, ten readings were taken on the member. The average of these is used as the rebound number of the concrete. Any reading that was differing by more than six units from the average of the ten readings was discarded. When two or more readings differed from the average by six units, the entire sets of the readings were discarded and ten new readings were taken afresh. The rebound number is affected by so many factors such as the smoothness of the surface of the concrete, the age of the concrete, the temperature, the moisture content, surface carbonation, aggregate, air voids, steel reinforcement and calibration of the rebound hammer [18]. For example, the higher the carbonated surface, the higher the rebound number. Also, the higher the moisture content of the concrete, the lower the rebound number and with a rough surface, the rebound number will be low while giving high rebound number with a smooth surface concrete. The quality of concrete as given by [19]. (Table 1) classified concrete quality into poor, fair, good and very good concrete depending on their respective rebound number or index.

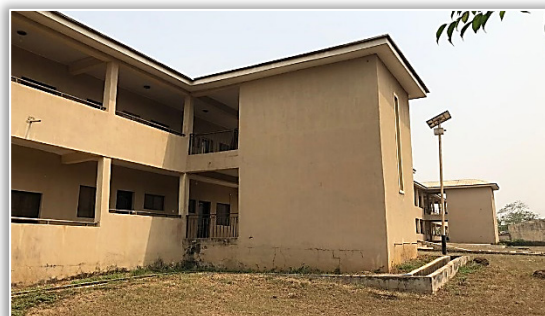
Figure 4: View of Hostel A

The two University Hostels, labelled A and B, that were considered for the investigation are as shown in Figures 4 and 5 respectively. Both were built around the same time in 2010.

Hostel A has 72 columns, 44 first floor beams and 18 slab panels while Hostel B has 161 columns, 89 beams and 32 slab panels. The procedure of [17] was followed strictly for the application of the rebound hammer for

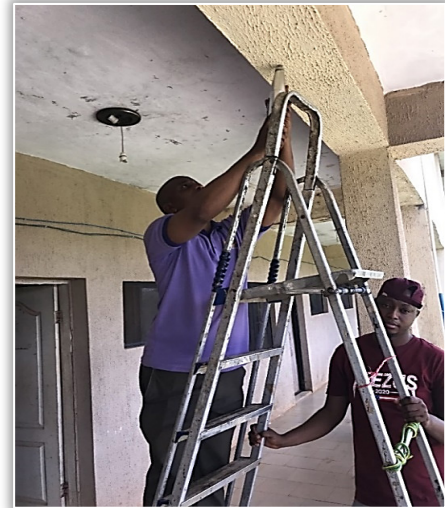
Figure 6: Field investigation on a beam

collection of the rebound numbers. Ten readings were taken by the rebound hammer (Figure 6) on each structural element.

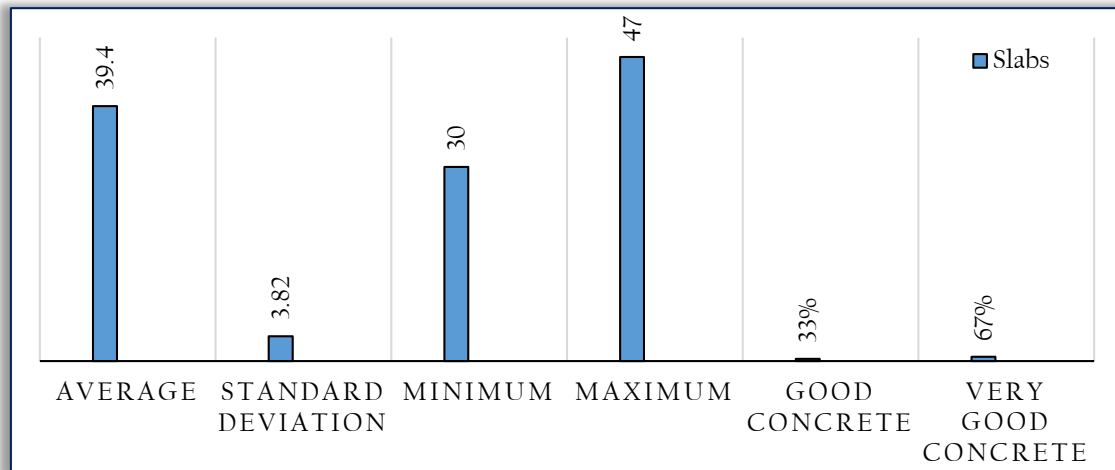
Figure 9: Rebound number plot for slabs of Hostel A

As shown in Figures 9 and 10, the panels of the slabs have their average rebound number to be 39.4 while their standard deviation is 3.82. Figure 10 reveals that the slab panels are excellent as 67% are of very good layer while 33% are of good layer. The concrete of the slab is of high compressive strength judging by these rebound number values. However, for the selected beams, in Figures 11 and 12, the minimum and the maximum rebound values are 24.0 and 38.0 respectively, while having their average as 32.9 and standard deviation as 3.07. Similarly, it can be observed that only 3% of the beams are of fair quality concrete while the rest are of good qualities. This shows that the concrete qualities of the beams are in line with the required standard and the beams can still fulfil their intended purposes. However, comparing the qualities of the concrete of the columns, beams and slab (Figure 13), the concrete qualities of the slab panels are far better than both the concrete qualities of the beams and columns, with the columns giving the worst strength, though fair.

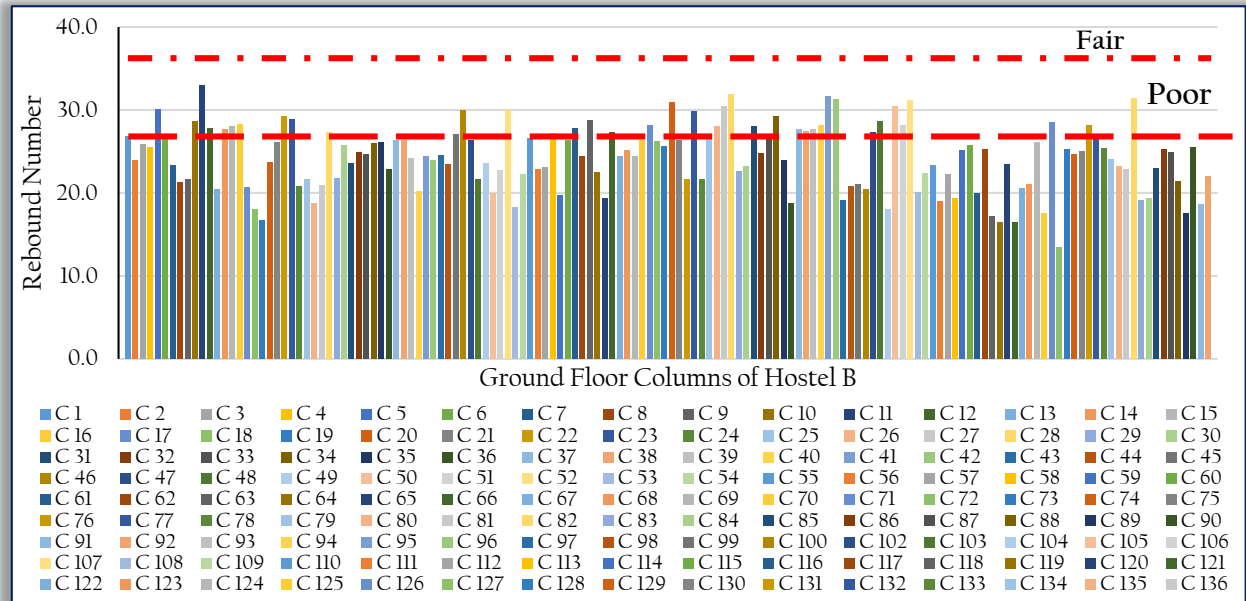
Figure 15: Concrete qualities for ground floor columns of Hostel B

With [19] and Figure 15, it is observed that only 8% of the ground columns are of good hard concrete, 78% are of fair hard layer and 13% are of poor concrete layer. The differences in the quality of concrete of the columns imply that regular non-destructive test should be carried out for prompt maintenance so that the building will still be fit throughout the working life. Similarly, as for the slab, the average rebound number is 28.8 for the slab while their standard deviation is 3.44. The minimum rebound number is 30.00 while the maximum rebound

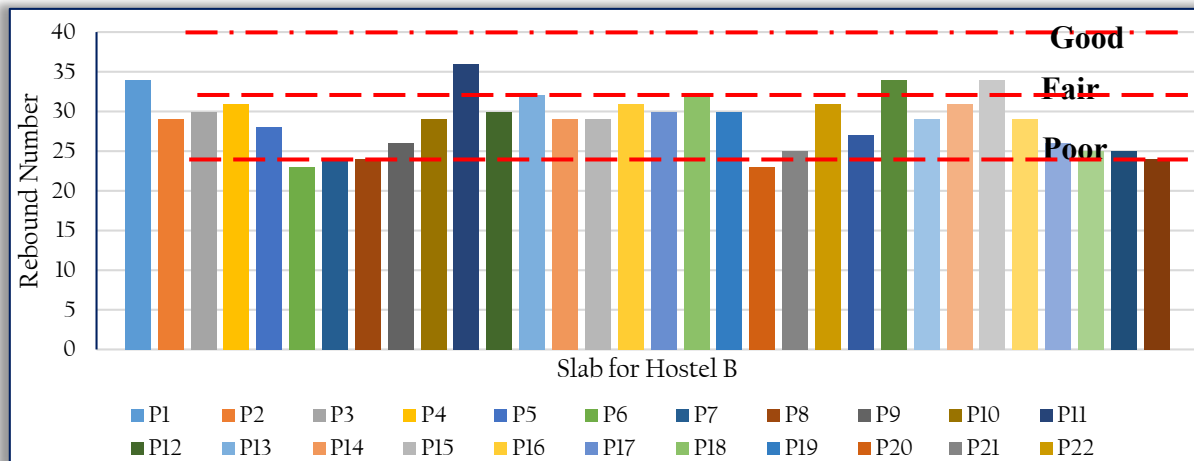
Figure 16: Concrete qualities for Slab of Hostel B

number is 47.00. It is observed from Figure 16 that the slab has 56% good hard layer and 44% very good layer. All the panels of the slabs give excellent results. For the first floor beams, the average rebound number is 29.3 while the standard deviation is 2.57. The minimum rebound number is 22.00 while the maximum rebound number is 35.00. From Figure 17, the beams have 51% fair hard layer and 49% very good hard layer.

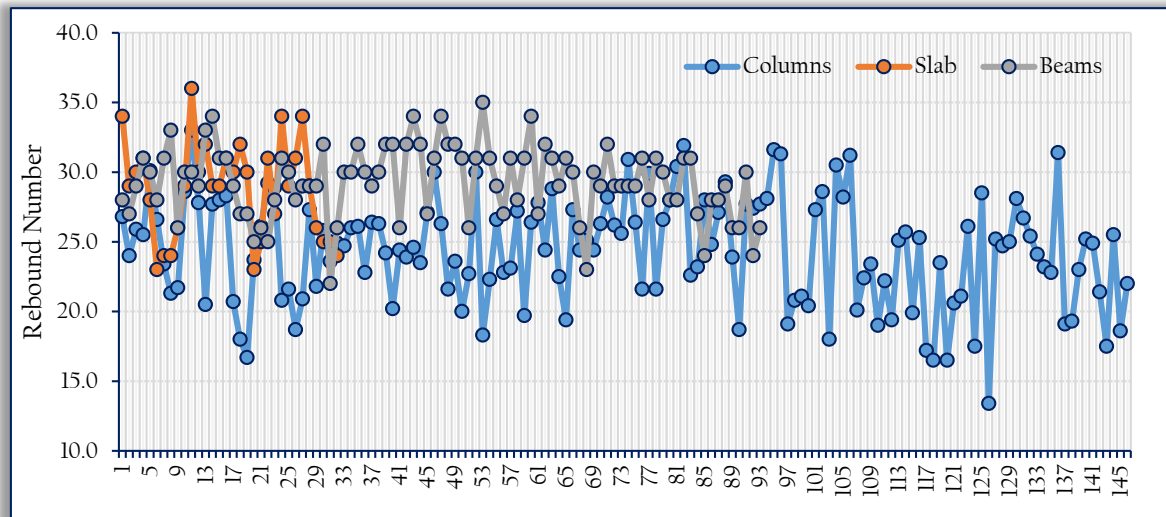
Figure 18: Comparison of Rebound Numbers for Columns, Slab and Beams for Hostel B

Considering Figure 18, which gives the comparison of the rebound number for the structural elements considered in Hostel B, it can be seen that the slab panels give better rebound number than the beams and the columns. Meanwhile, by comparing the rebound number for the two Hostels as shown in Figure 19, the rebound values for slab in Hostel A are far better than all other elements.
