¹Tibor DZURO, ²Kristián PÁSTOR

UTILIZATION OF THERMOGRAPHIC DEVICE FOR FAULT DIAGNOSIS IN OLD VEHICLE

^{1,2}Technical University of Kosice, Faculty of Mechanical Engineering, Institute of Industrial Engineering, Management, Environmental Engineering and Applied Mathematics, Department of Business Management and Environmental Engineering, Kosice, SLOVAKIA

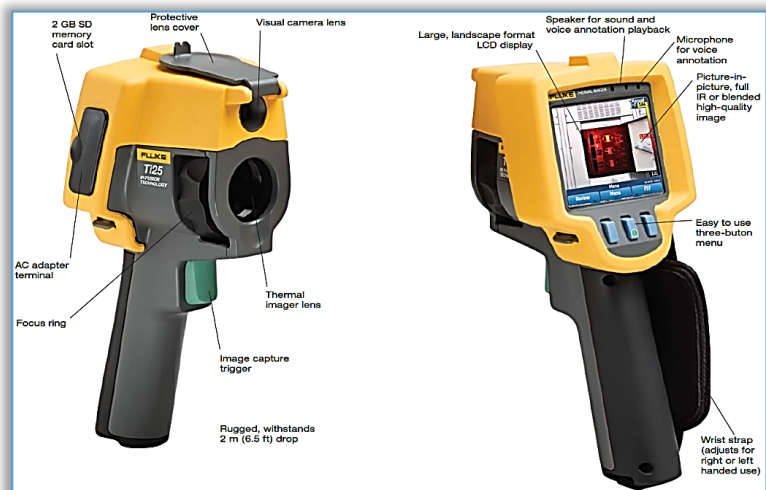
For experimental measurements, a thermal imaging camera from FLUKE was used. The following Figure 1 shows the FLUKE Ti25 thermal imaging camera. The technical parameters of the thermal imaging camera are clearly shown in Table 1.

Figure 1. Thermal imaging camera FLUKE Ti25 [17]

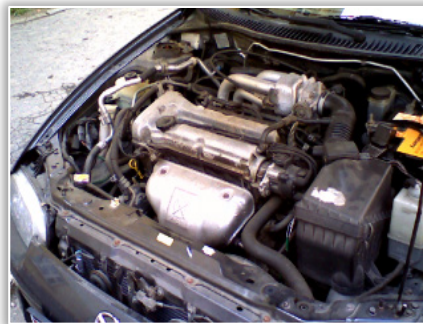
Figure 2. View of the motor part

sequence in a time span of 14 minutes at a frequency of 10 seconds per thermal image. In this way, we ensured a detailed mapping of the thermal areas of the engine block, engine head and exhaust pipe to identify the problem part of the combustion engine. The tests took place at an ambient temperature of 17°C. The following Figure 2 shows the motor part of the motor vehicle.

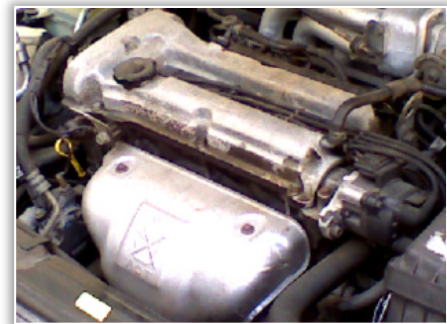
The subject of the thermal imaging measurement was a Z5–DE DOHC 16V gasoline combustion engine (Figure 3) manufactured by Mazda from 1998 (Figure 4). The measurements took place in a continuous

Figure 3. Engine type Z5–DE DOHC 16V
