## ELIMINATION OF INCORRECT LEVEL (GAP) BETWEEN RR GATE AND RR BODY, BASED ON DEMING CYCLE AND STATISTICS TOOLS - CASE STUDY

**ABSTRACT:** The current investigation has an objective to present a methodology solution to eliminate the incorrect level (gap) of clearances and gates from the Rear Gate and Rear Body Side made during the auto motor vehicle manufacture. Based on the PDCA Control Cycle (Deming Cycle) and supported on the application of the process statistics tools, the activities were scheduled in order to systematically resolve the issue in the product's box. Applying the methodology, the planned activities were implemented to eliminate the problem and the impact of the incident was 100% effective, the main obstacle was the low model production volume, but eliminated the problem. The established work methodology to non-conforming elimination is a solution proposal that it has been documented in books, however currently, is a better option to implement FTA (Factor Tree Analysis) instead of the Ishikawa diagram in order to achieve a methodology of solution more efficient, achieving a work proposal that allowed the total elimination of the issue presented.

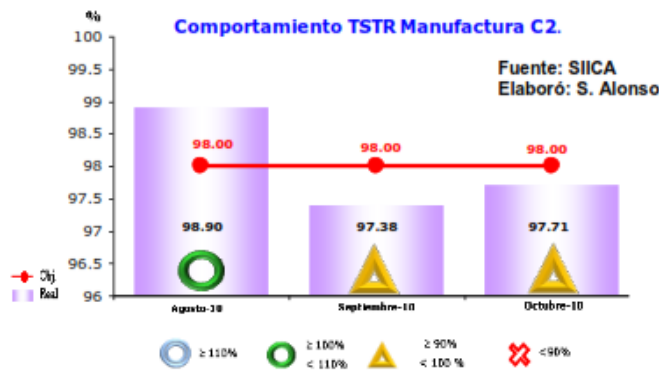
Figure 2. TSTR manufacturing behavior, source SIICA

Complemented of the activities, in evaluating individually the TSTR manufacturing, we can see that in the months of September and October, it was out of order (Figure 2).

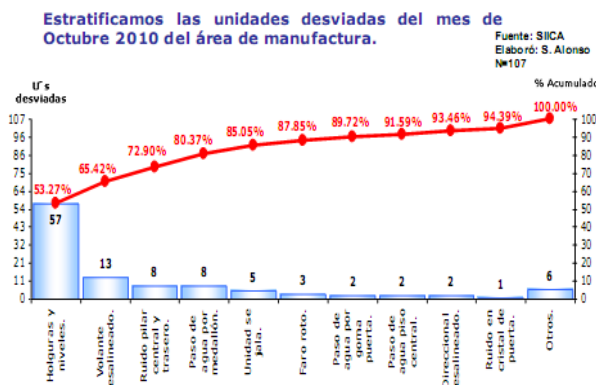
Figure 4. Pareto analysis, source SIICA

The cause of the problem it was defined through of Pareto chart using the possible variables that should have been the cause of the non-conformity, the analysis is shown in the following figure (Figure 4).

According to the previous graph, the item "clearances and levels", is the largest contribution with 53.27% in the body area.

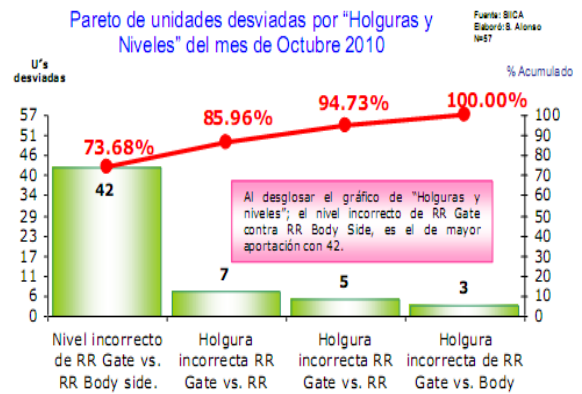
Figure 5. Pareto analysis for the characteristic of clearances and levels, source SIICA

Again, It was performed a second Pareto, to define between the "clearances and levels", what was the cause of the problem and was found that the main problem is the incorrect level of the sides and gate with a 73.68% of the contribution. Figure 5 shows the results obtained

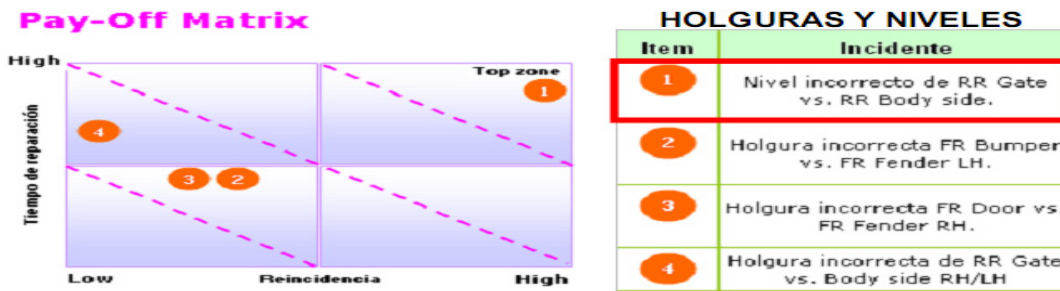
Figure 6. Pay off Matrix, source SIICA

In order to confirm this issue, it was applied the Pay Off Matrix (see figure 6), considering the recurrence in the repair time, thus confirming that the wrong level of RR Gate vs RR Side is an area of opportunity.

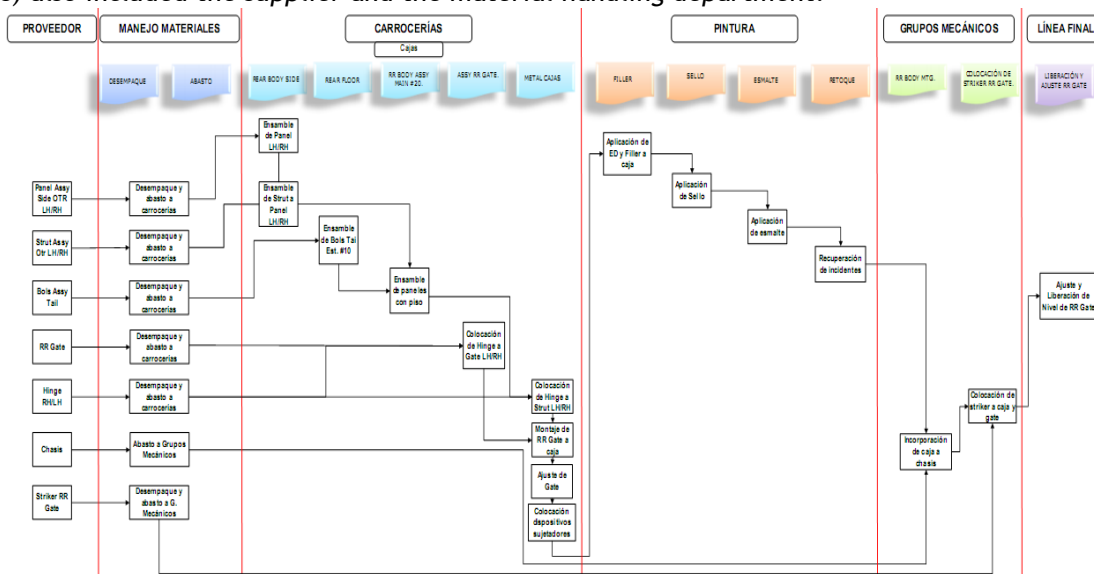
Figure 9. Process mapping, source SIICA

Then we conducted a process mapping (Figure 9) to identify the transactions related to the incident, in which not only checked four processes (bodywork, paint, mechanical and finish line groups) also included the supplier and the material handling department.

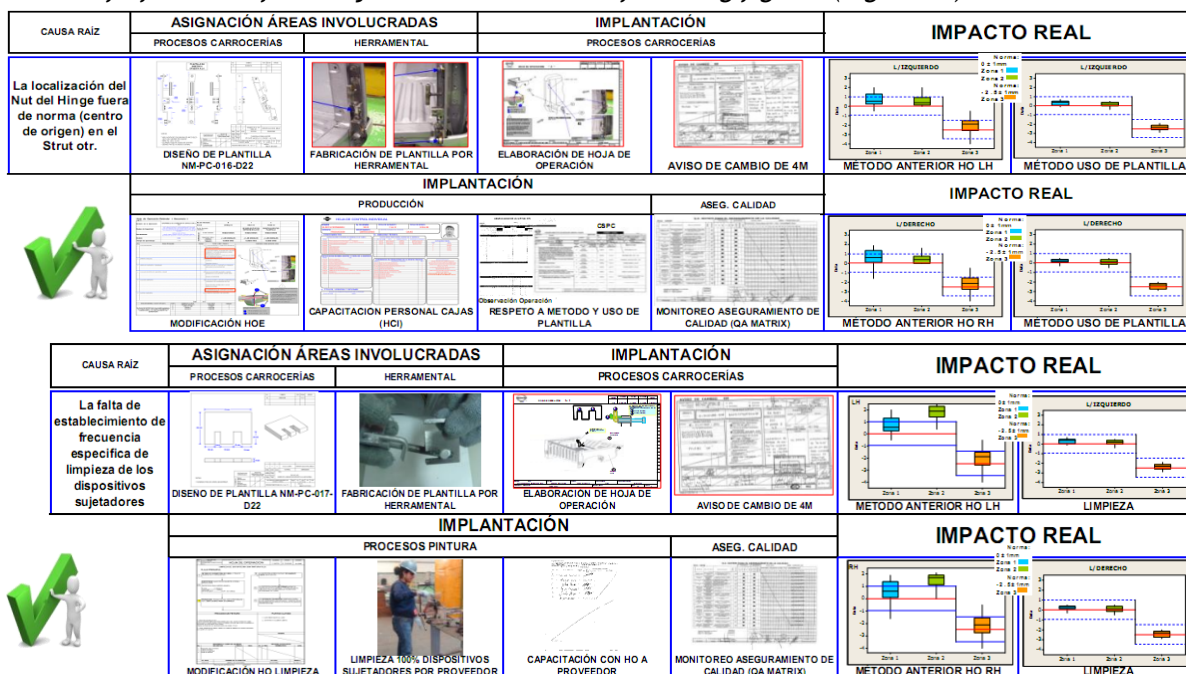
Figure 17. Fulfillment of the objectives

We checked the results of corrective actions by observing a forcefulness on the results obtained free of crime and enforcement of the planned production volume.

The fulfillment of the objectives shown in the following figures (Figure 17).
