¹Kofi AGYEKUM, ²Burcu SALGIN

DIAGNOSING RISING DAMP IN RESIDENTIAL BUILDINGS: LESSONS FROM THREE CASES

¹Department of Building Technology, Kwame Nkrumah University of Science and Technology, Kumasi, GHANA

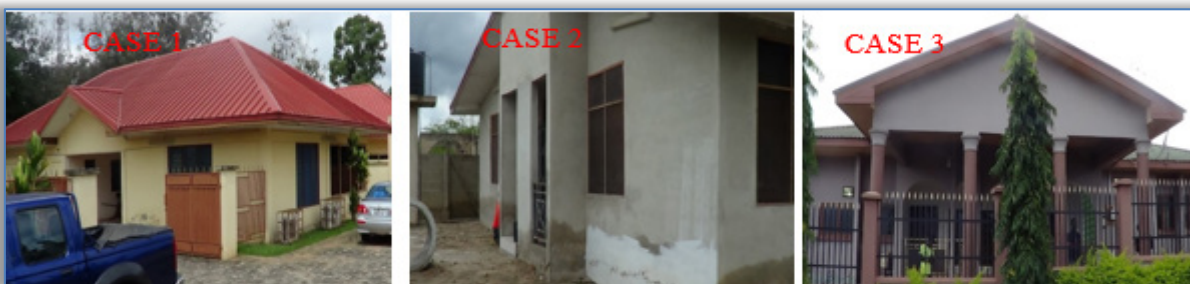
Figure 2. The three buildings adopted for the study

This study sought to diagnose the problem of rising damp in the walls of three residential buildings using a four-stage approach to damp investigation. A multiple case study approach, which involves three buildings, was adopted for the study. These buildings were selected because they had been severely affected by dampness, and therefore offered suitable cases for the study. The first case of this study was a three-bedroom semi-detached residential bungalow situated at Danyame and belonging to the Department of Urban Roads in Kumasi, Ghana (Figure 2). The second case was a three-bedroom residential building located at Deduako, a suburb of the Oforikrom sub-metro which also falls under the Kumasi Metropolitan Assembly (Figure 2). The building in Case 3 was situated at Kwamo, a suburb of the Ejisu-Juaben Municipal Assembly, one of the 27 administrative and political districts in the Ashanti Region of Ghana (Figure 2).
